Neary Elementary School
53 Parkerville Road
Southborough, Massachusetts 01772

Facility Condition Assessment

April 2, 2021

Re: Facility Condition Assessment
Neary Elementary School
53 Parkerville Road
Southborough, Massachusetts 01772
VERTEX Project No. 69604

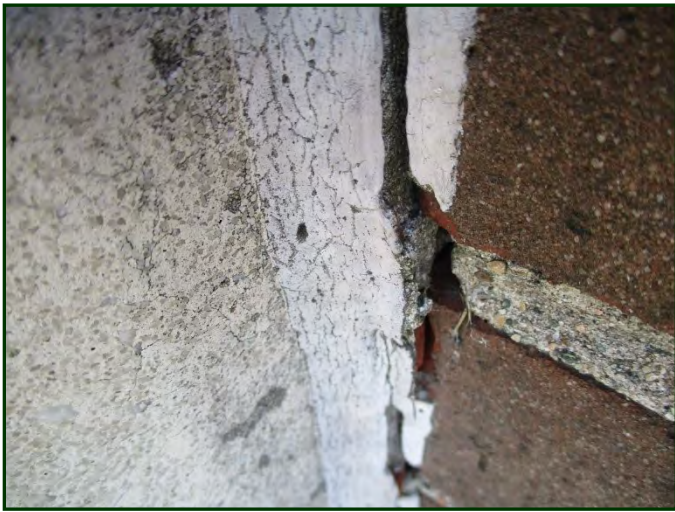
Photo #7: Close-up view of perimeter joint sealant at wall openings with aged, cracked and separating sealant

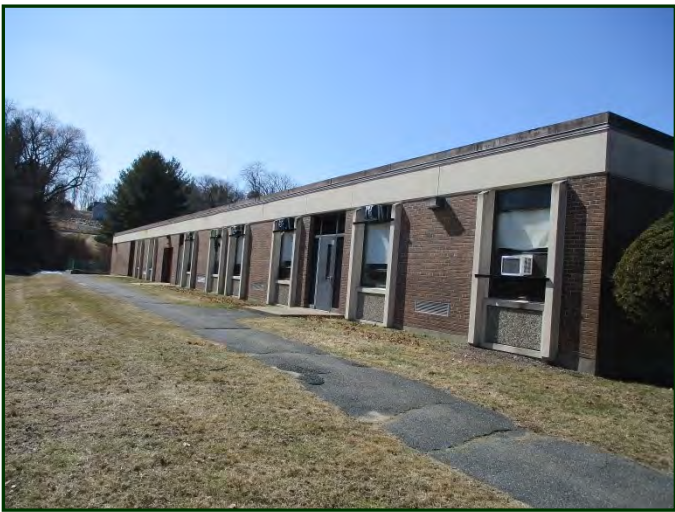
Photo #12: South elevation. Note uneven asphalt sidewalk

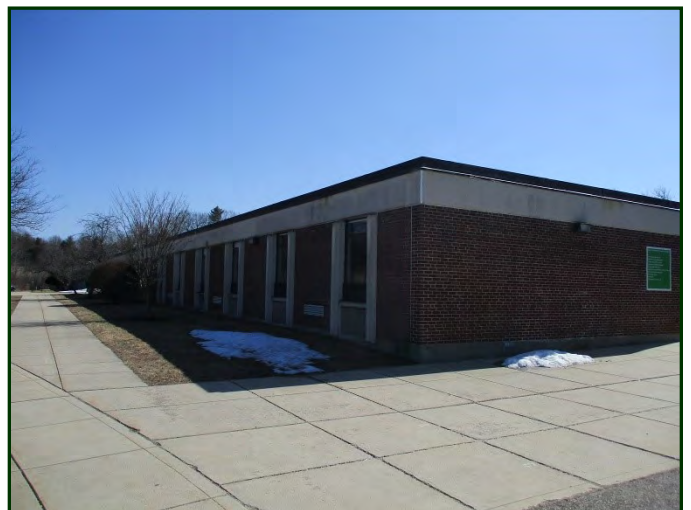
Photo #24: Concrete sidewalks with some minor surface scaling

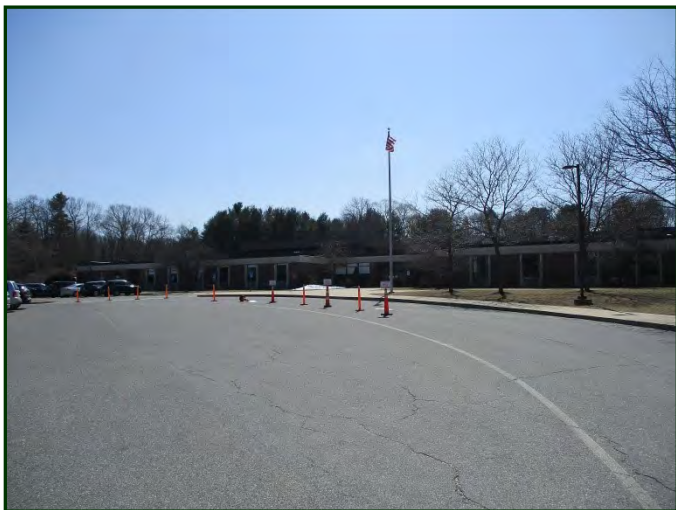
Photo #31: Asphalt paving at east side at drop off-pick up area with minor random cracking

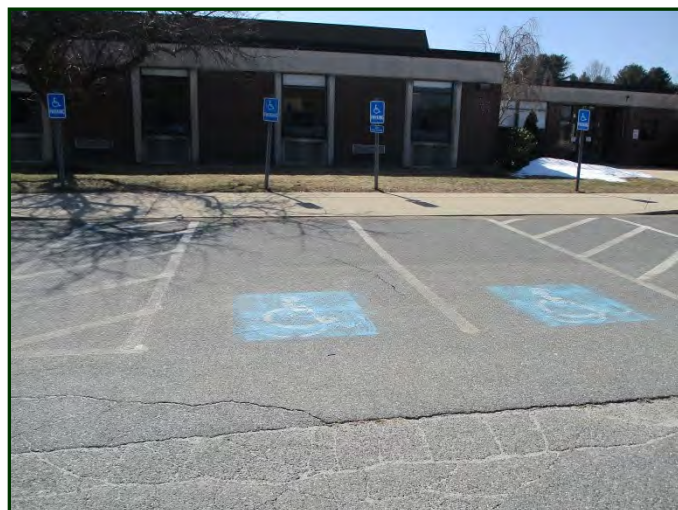
Photo #34: Accessible parking spaces, with faded painted lines & symbols, adjacent to the main building entrance. Note some asphalt pavement cracking

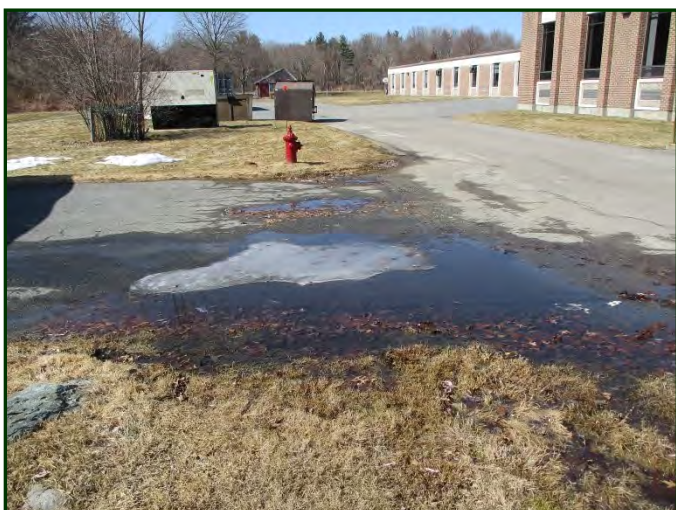
Photo #35: View of ponding water on asphalt pavement at west elevation

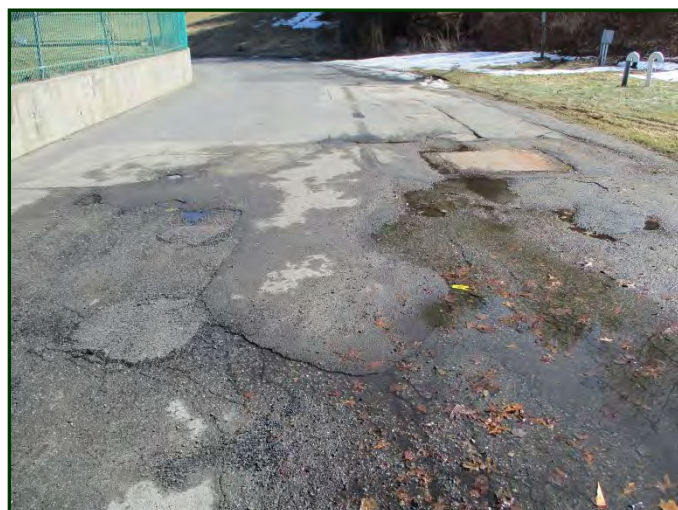
Photo #36: Continuation of ponding water at west elevation with some potholes, note septic system beyond

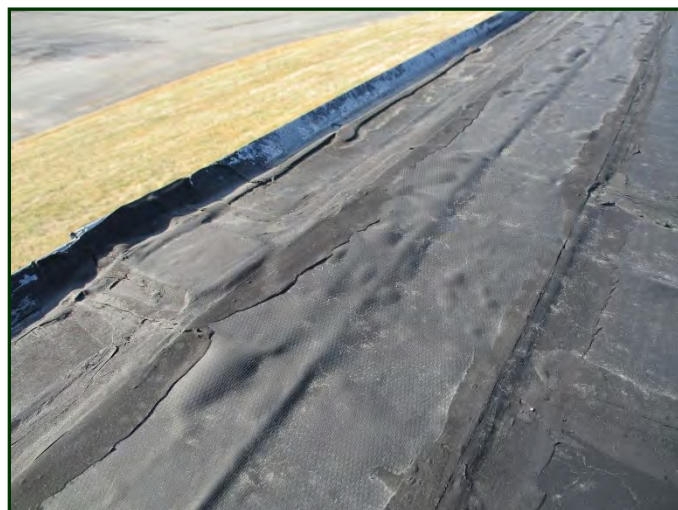
Photo #40: Edge of roof with aged and separating sealant at joints

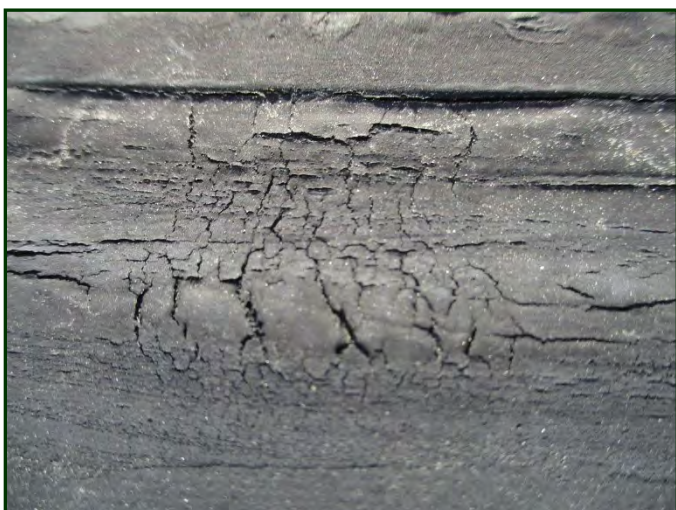
Photo #41: Aged and cracked sealant at historical patches

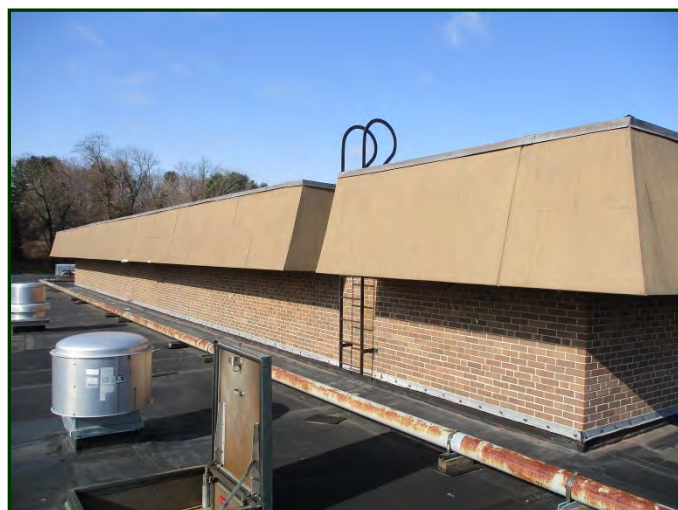
Photo #42: Raised portion at high roof with cracked stucco and brick veneer

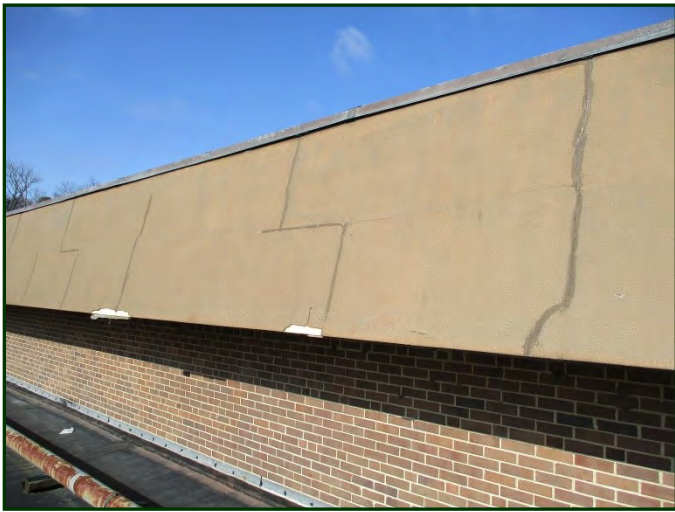
Photo #43: Close-up view of cracks in stucco at high roof

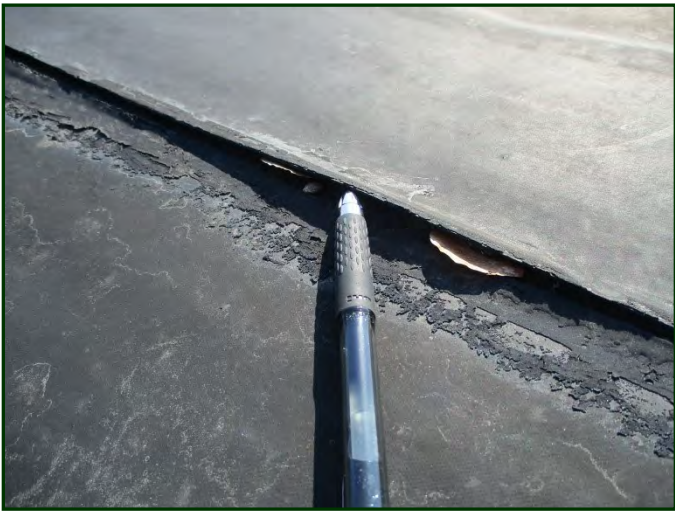
Photo #46: Aged roof membrane with deteriorated joint sealant & open joints to the weather

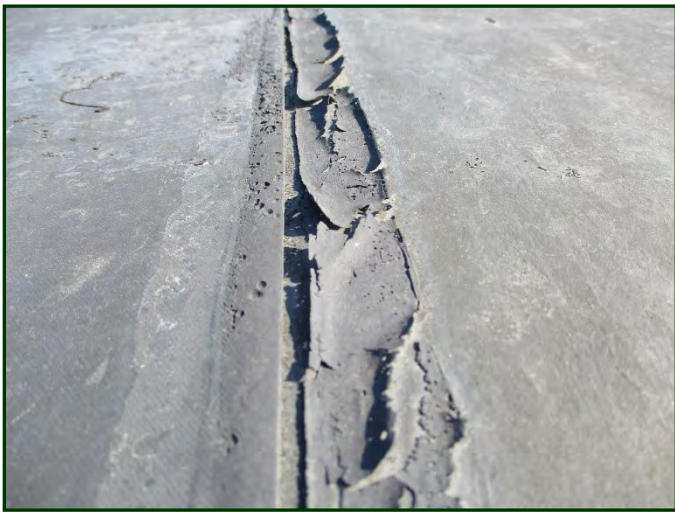
Photo #47: Close-up view of deteriorated joints in roof membrane

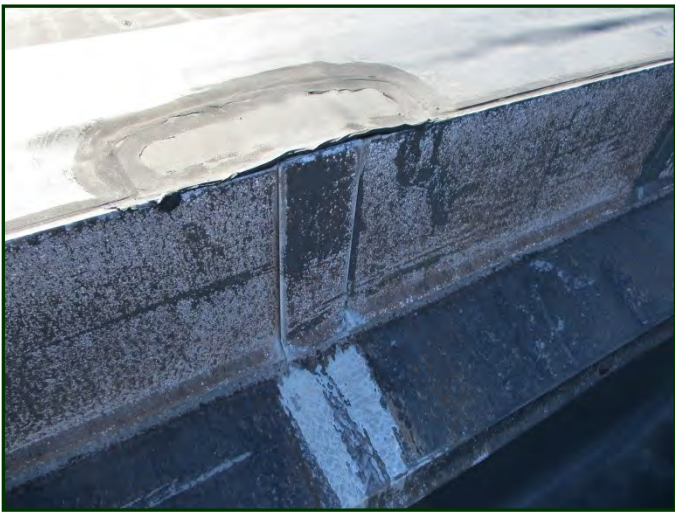
Photo #48: Metal plates at coping seams with open joints

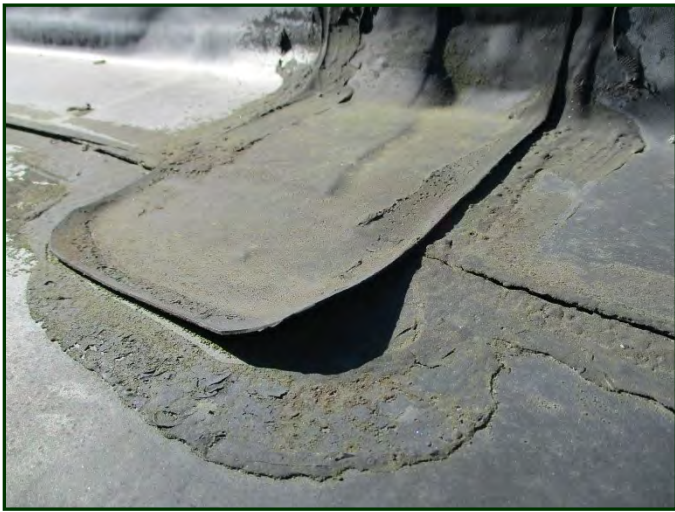
Photo #49: Historical patches lifting (with openings) at turned-up roof membrane

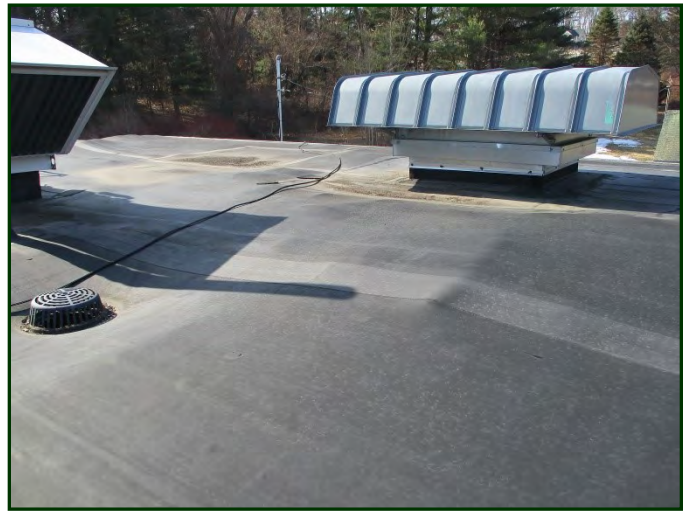
Photo #50: Severe tenting of roof membrane, preventing drainage to internal roof drains

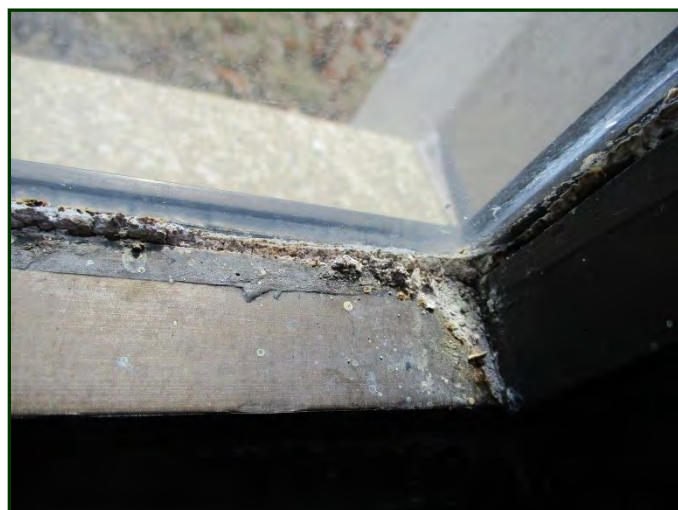
Photo #60: Interior view of aluminum-framed windows with deteriorated glazing (powdery & spalling) & aged gaskets

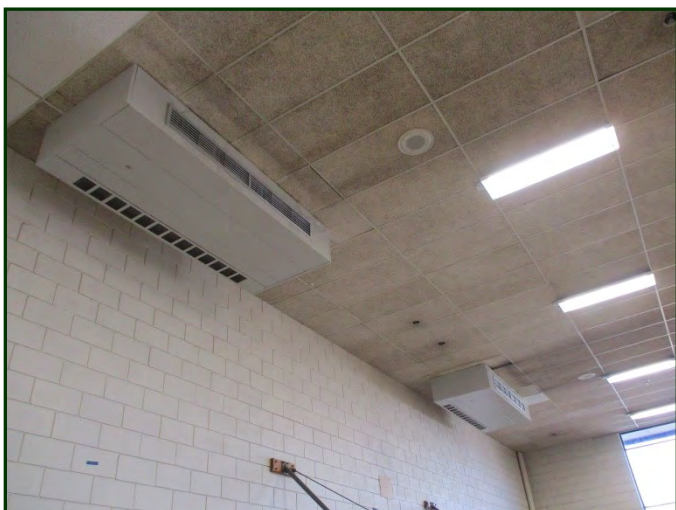
Photo #67: Ceiling-mounted air handling units in gymnasium with hot water coils. Note aged & stained ceiling tiles

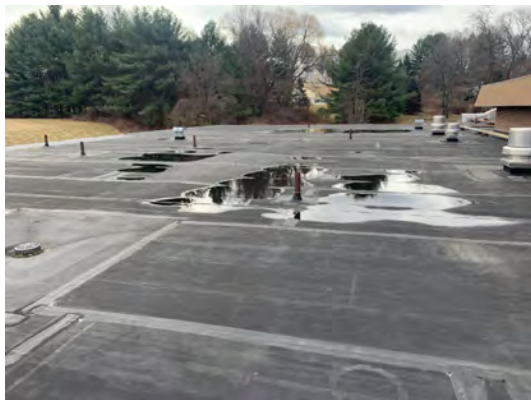
Photo 1

This roof is completely failed with areas of severe ponding, lifted insulation, failed seams and perimeters and many other deficiencies.

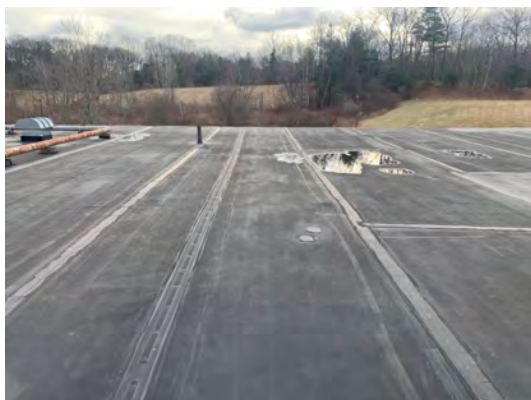
Photo 2

Re-seaming has been completed on much of the roof.

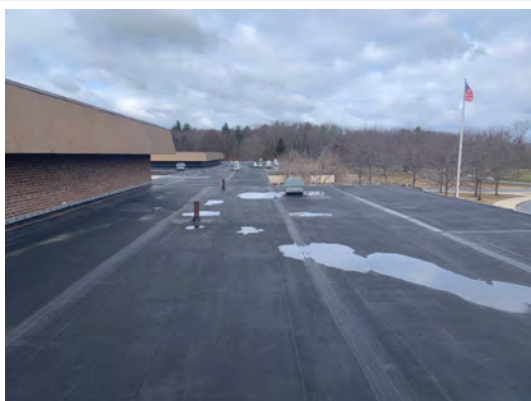
Photo 3

Allow hard to see in the picture, there are areas of lifted insulation. These areas of lifted insulation should be monitored closely as it means the insulation is no longer attached to the roof deck and is in danger of causing a catastrophic failure.

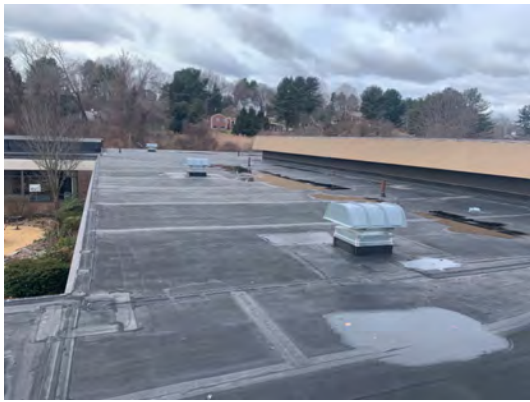
Photo 4

More areas of ponding and lifted insulation.

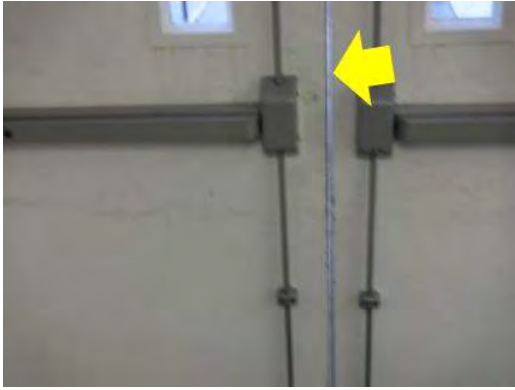
- Attic/Roof – The roof is flat; additional disruptive investigation would be necessary to determine the condition of the roof insulation. Air sealing is recommended at the perimeter of the building where the roof assembly meets the wall assembly.
- Walls – The walls are brick exterior and structural block; there is no cavity in this wall assembly that would allow retrofit insulation.
- Windows – The windows are single pane fixed sash and hopper units. Air conditioning units are installed through select window systems.
- Doors – There are air leaks at the perimeter of the door systems throughout the facility.

Door Weather Stripping Opportunity

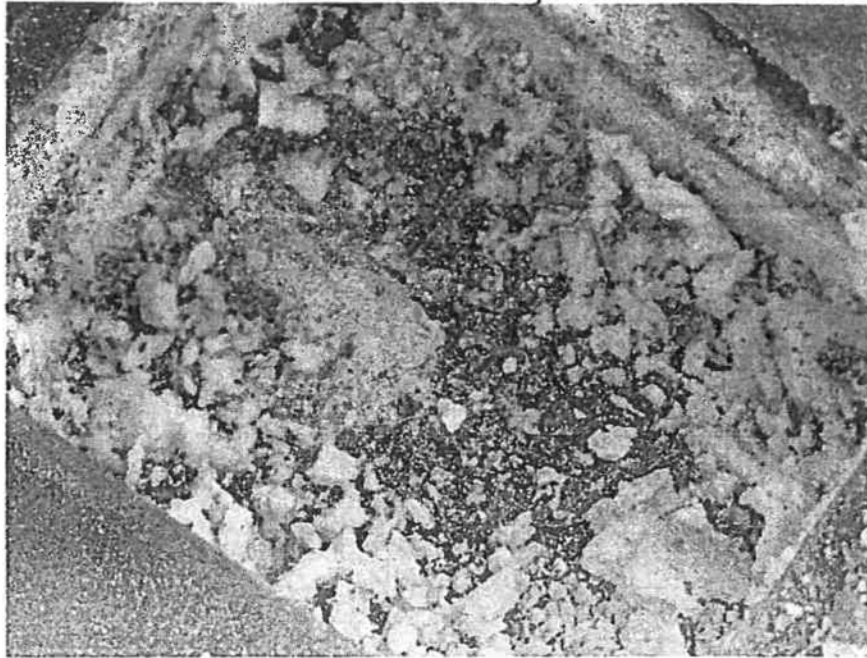
Two layers of insulation adhered to the light weight
concrete deck with asphalt

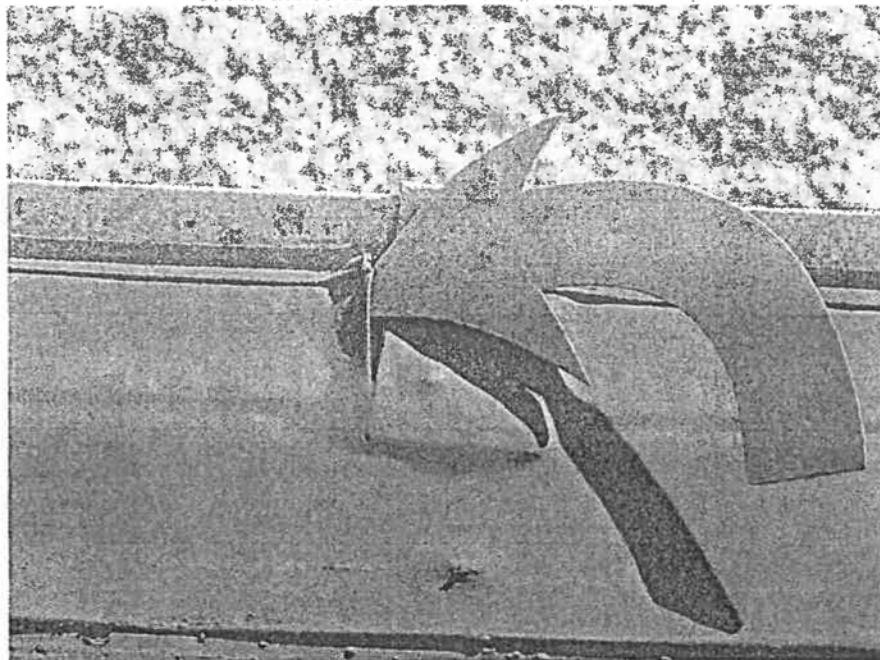
Cut in the roof membrane at seams of fascia

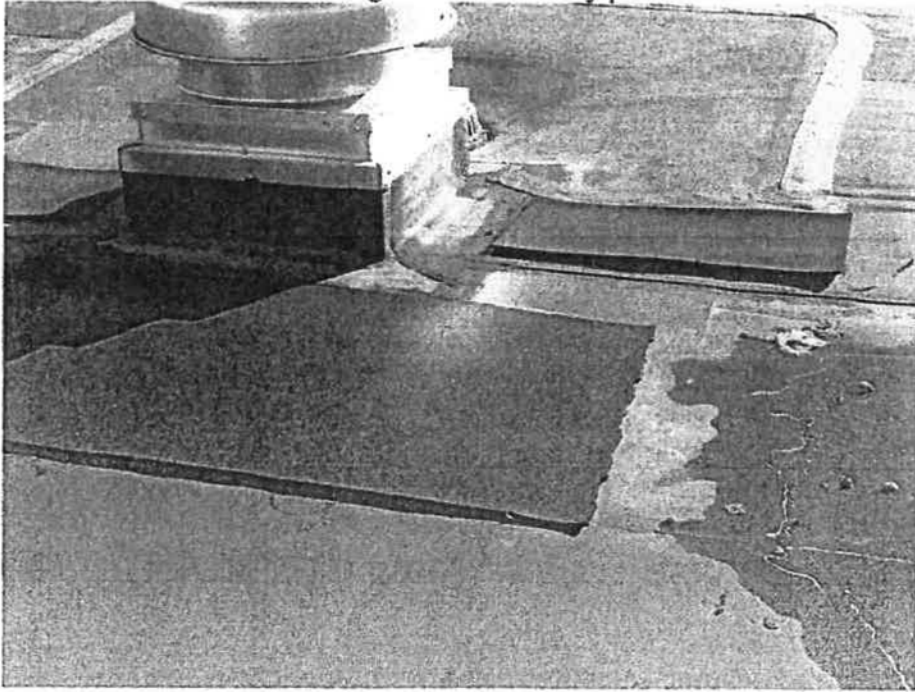
Lifted edges of the walk way pads

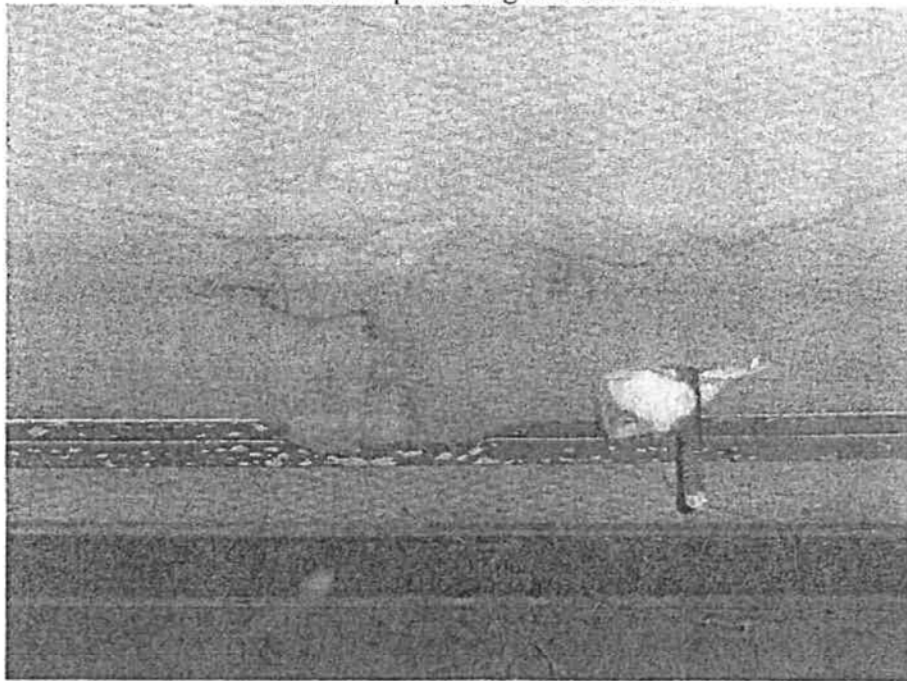
Underside of the roof deck. Note the water stains and fastener protruding thru the deck
