# Evaluation of Southborough Sites

# Existing Conditions Report

# Structural Conditions

## INTRODUCTION

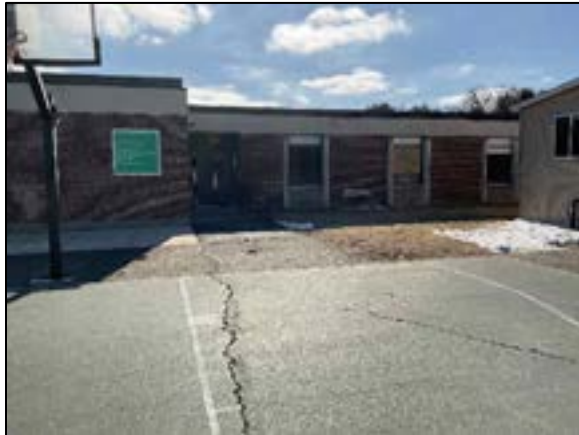
The 1968 original drawings indicate that the building is constructed with masonry exterior walls and steel framing, which is consistent with what was observed on site. Corridors are generally constructed with CMU throughout. Combustible construction was observed in small MEP spaces and the 1968 drawings indicate plywood at select locations. A small modular structure constructed as an addition consists of masonry exterior walls and noncombustible structure. A building separation was not observed between the existing building and the modular addition. The construction type of the building defaults to **Type IIIB** construction due to the combustible construction. However, if the wood construction is removed, the building would be permitted to be classified as **Type IIB** construction under the current edition of 780 CMR.

FIGURE 2: MASONRY EXTERIOR WALLS

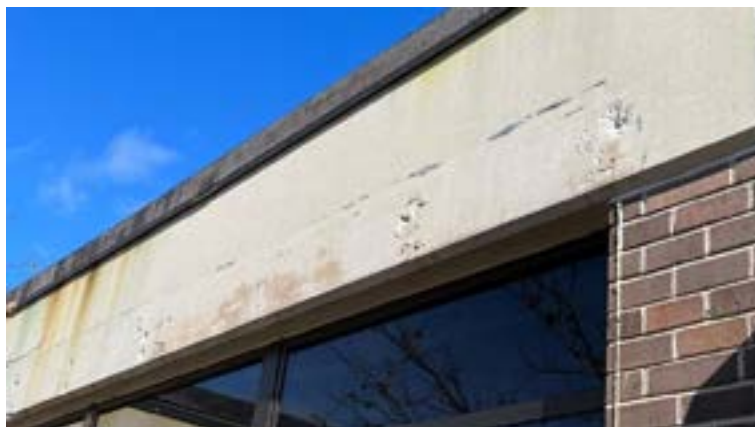
1. On the courtyard exterior wall adjacent to the main entrance, a precast band beam has a few spalls in the concrete. We recommend chipping out loose spalls, applying a bonding agent, and infilling with a high-strength mortar.

Figure 1 – Spalls in Precast Band Beam

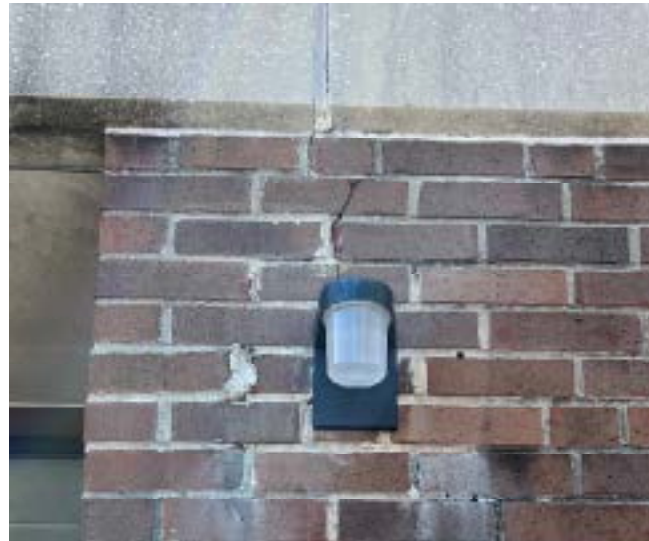
2. On the right side of the main entrance door, a crack in the brick veneer was observed. We recommend repairing the crack by cutting out loose mortar and repointing with fresh mortar.

*Figure 2 – Crack in Brick Veneer*

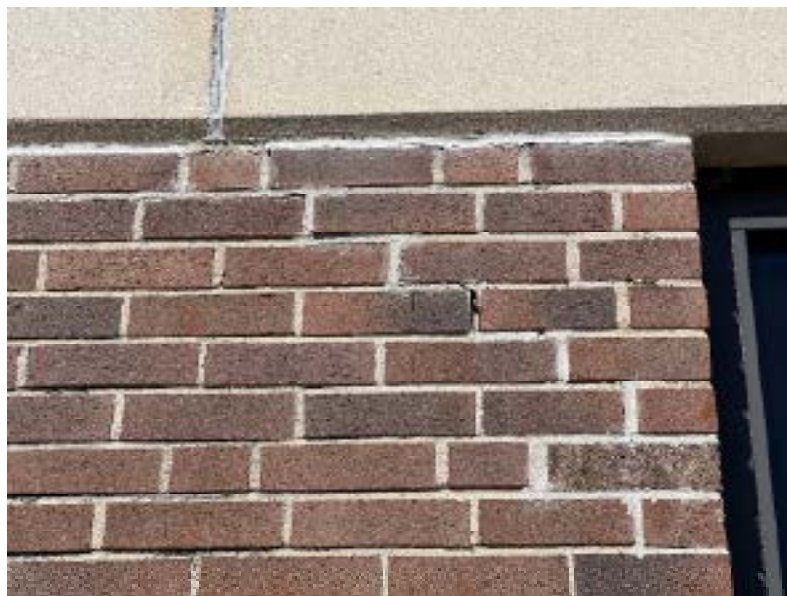
3. On the southeast face of the exterior façade, near a playground equipment door, a step crack has started to form through the joints of the brick veneer. We recommend recaulking the joint between the precast beam and the top of the brick veneer to avoid any precast beam load bearing on the veneer.

*Figure 3 – Diagonal Crack Building on Brick Veneer*

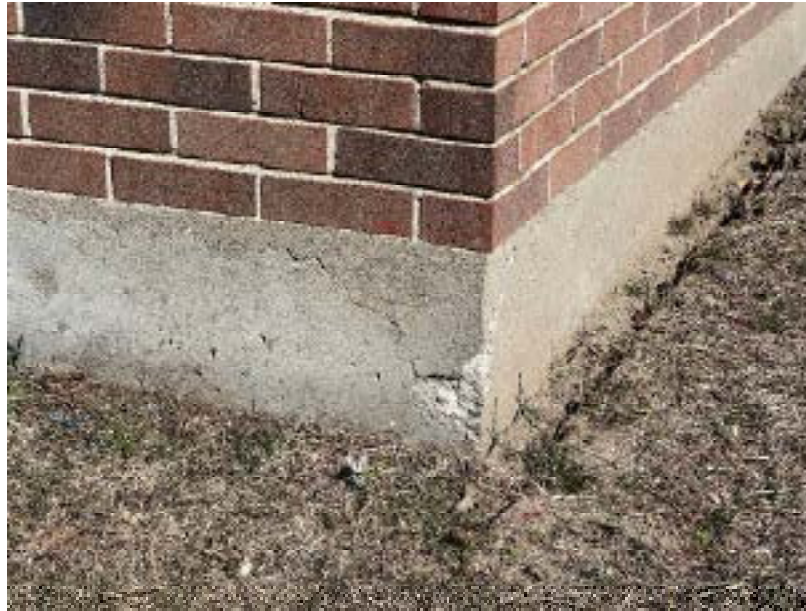
4. At the south corner of the building, a diagonal crack in the foundation wall was observed. We recommend epoxy pressure injection to seal the cracks.

*Figure 4 – Diagonal Crack in Foundation Wall Corner.*

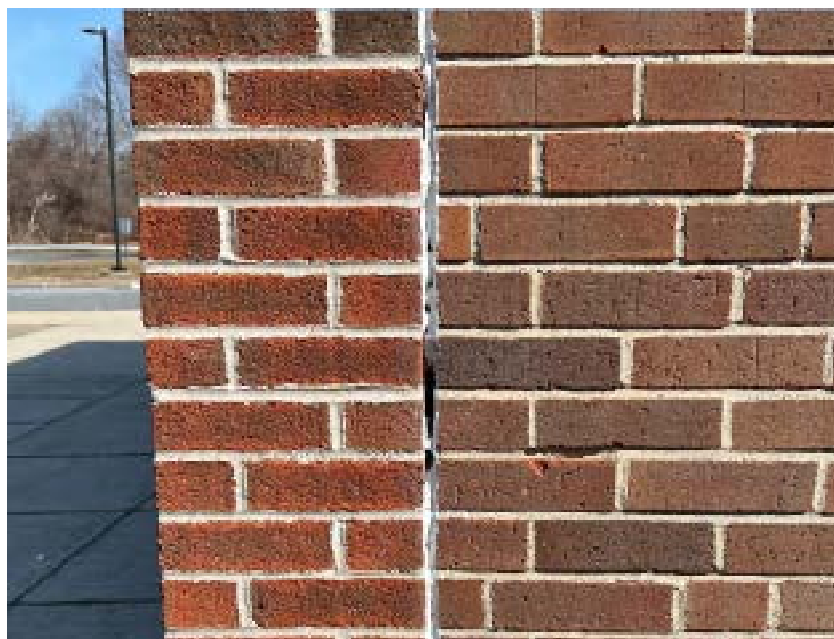
5. On the northwest face of the building, caulking was missing from a small portion of a vertical wall joint. Fill the joint with new caulking

*Figure 5 – Missing caulking at a Wall Joint*

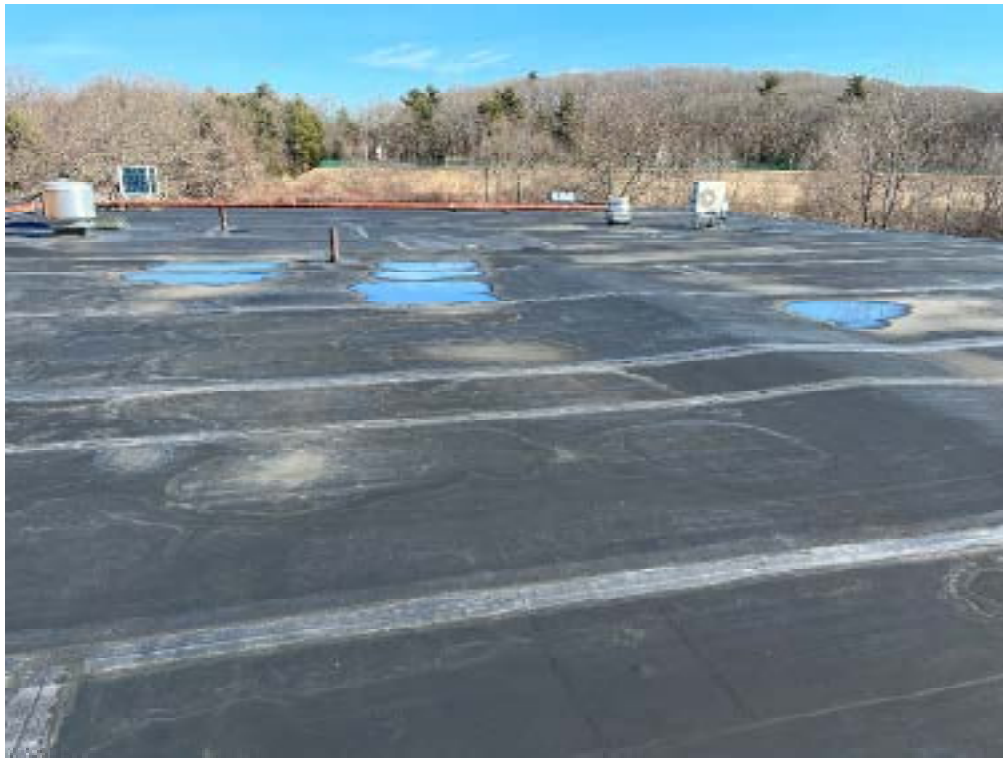
6. On the roof, at a few locations water puddles were observed. We recommend evaluating the roof slope to avoid future ponding of water.

*Figure 7 – Water Puddles on Roof*

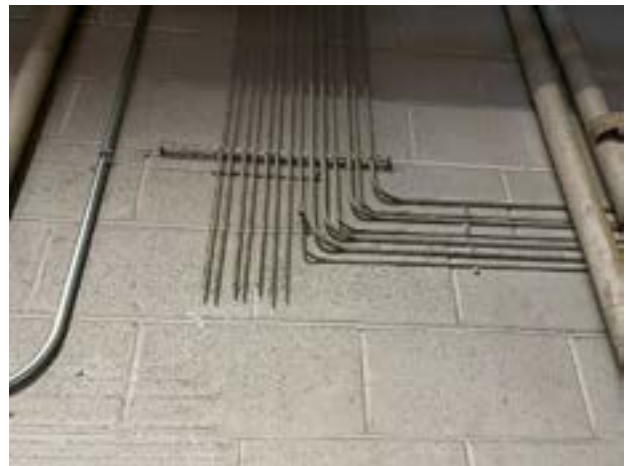
*Abandoned/Cut Pneumatic Control Lines*

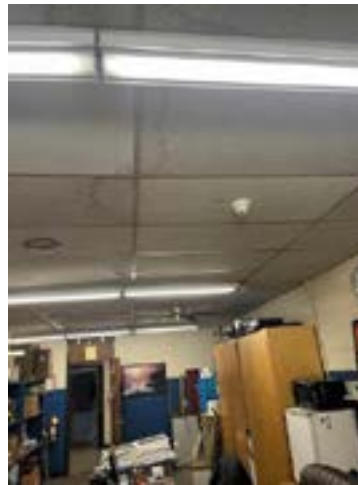
There are a number of light fixtures that have missing lenses.

*Fixtures Missing Lens*
