**VOLUME II**  
APPENDICES

## A. Statement of Interest

## H. Accessibility Evaluation - Itemized Deficiencies

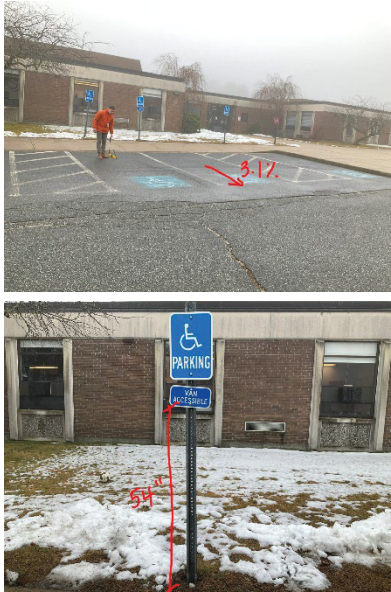
#	Barrier	Photo
1.	<p><b>Accessible Parking Spaces</b></p> <p>There is an insufficient number of accessible parking spaces provided. For a parking lot with 151-200 total spaces, six accessible parking spaces are required, one of which must be van accessible. Currently, one van and three standard accessible parking spaces are provided.</p> <p><i>Quantity: 3 (2 spaces, 1 aisle)</i></p> <p>The designated accessible parking spaces are not distributed between the two accessible entrances.</p> <p><i>Quantity: 6 (4 spaces, 2 aisles)</i></p> <p>The designated accessible parking spaces have slopes &gt;2%, @ 3.1%.</p> <p><i>Quantity: 6 (4 spaces, 2 aisles)</i></p> <p>The bottom of the van accessible parking sign is &lt;60" AFF, @ 54".</p>

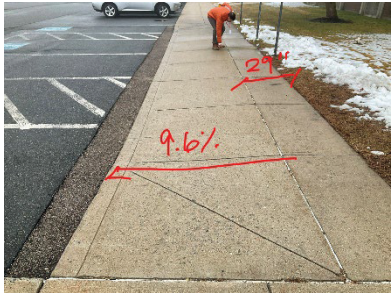
2.	<p><b>Curb Ramp near Accessible Parking</b></p> <p>The landing at the top of the curb ramp is &lt;48" long, @ 24".</p> <p>The curb ramp has running slopes &gt;8.3%, @ 9.6%, and creates cross-slopes &gt;2% along the accessible path of travel.</p>

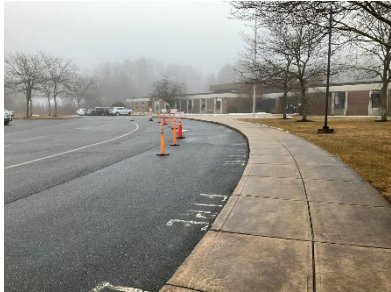
3.	<p><b>Bus Drop-off &amp; Passenger Loading Zones</b></p> <p>There are no curb ramps provided at the passenger loading zones and bus drop-off area.</p> <p><i>Quantity: 2</i></p> <p>There is no accessible passenger loading zone provided in every continuous 100 LF of loading zone space.</p> <p><i>Est. Quantity: 4</i></p>

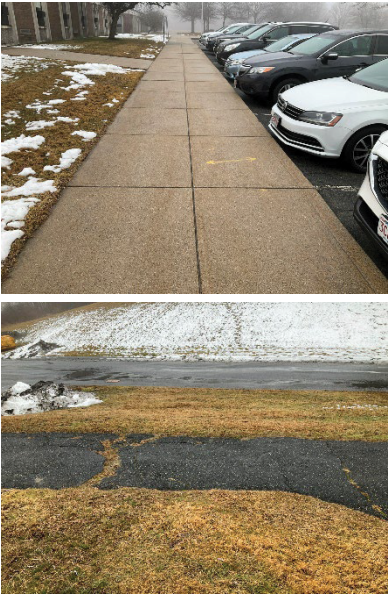
4.	<p><b>Walkways around Building (Typical)</b></p> <p>The walkways have cross-slopes &gt;2%, @ 2.8%, running slopes &gt;5%, @ up to 10.7%, and/or abrupt changes in level &gt;½” due to material deterioration.</p> <p><i>Est. Quantity: 960 SF</i></p>

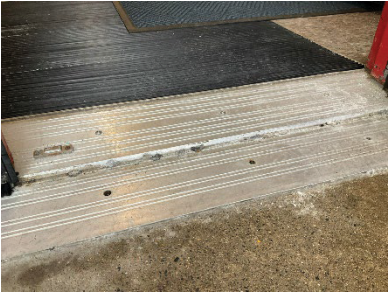
5.	<p><b>Exterior Door Thresholds</b></p> <p>The threshold is &gt;½” high, @ 1”-1 ¼”.</p> <p><i>Observed at the main entrance (Door A1), entrance near the Superintendent’s office (Door A2), Egress B3, Egress C1, and doors to courtyard.</i></p> <p><i>Quantity: 7</i></p>

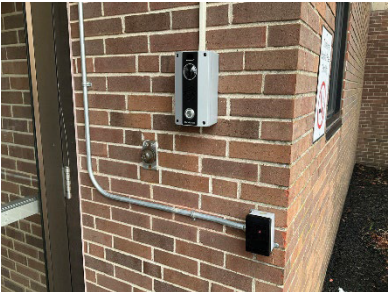
6.	<p><b>Entrance Intercoms</b></p> <p>The intercom is mounted &gt;48” AFF to the highest operable part, @ 56” and 57”.</p> <p><i>Observed at the main entrance (Door A1) and the entrance near the Superintendent’s office (Door A2).</i></p> <p><i>Quantity: 2</i></p>

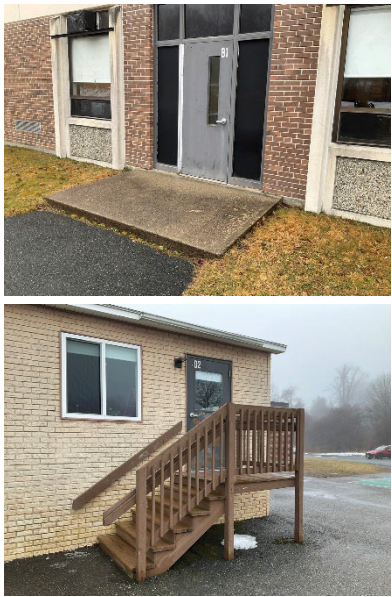
8.	<p><b>Egress Doors B1, B2, C5, D2, &amp; D3</b></p> <p>Many egress doors are not accessible due to steps at the landing or stairs.</p> <p><i>Quantity: 5</i></p>

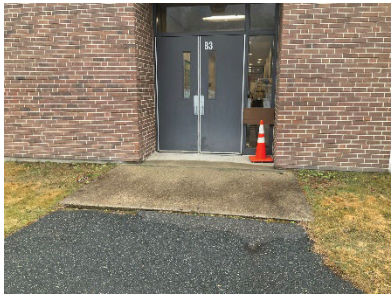
9.	<p><b>Egress Door B3</b></p> <p>The double doors lack at least one leaf that provides the required 32" minimum clearance, @ 31 ½".</p> <p>The door landing has abrupt changes in level &gt;½" due to the change in surface materials.</p>

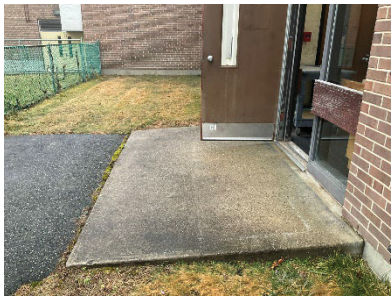
10.	<p><b>Egress Door C1</b></p> <p>The door lacks a level landing, @ 8%.</p>

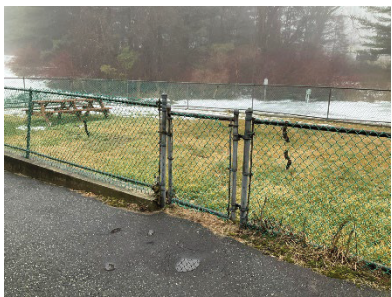
11.	<p><b>Gated Area near Egress Door C1</b></p> <p>The picnic tables are not located on an accessible route, due to the grass.</p> <p>The gate lacks the required minimum 10" of smooth surface along the bottom of the push side.</p> <p>The gate lacks a level landing.</p>

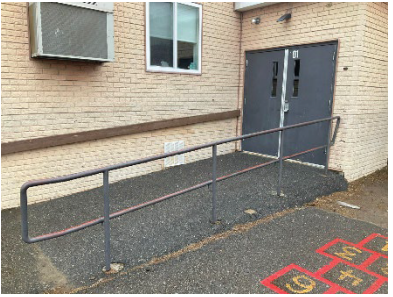
12.	<p><b>Egress Door D1</b></p> <p>The door lacks a level landing, @ 5.5%.</p> <p>The ramp lacks a level landing at the top of the run.</p> <p>The ramp has running slopes &gt;8.3%, @ 8.5%.</p> <p>The ramp lacks the required edge protection.</p> <p>The handrail on the wall lacks the required gripping surface diameter, lower portion, and extensions.</p>

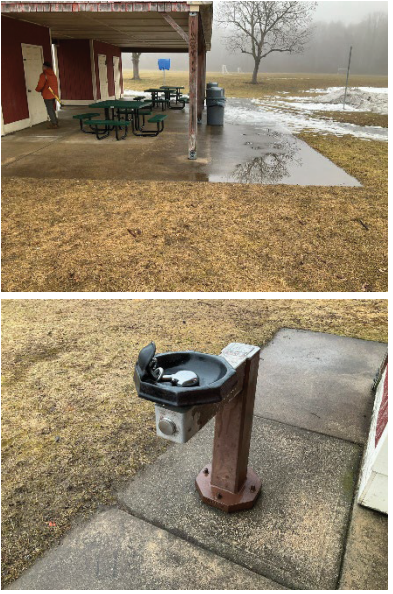
14.	<p><b>Covered Picnic Area</b></p> <p>There is no accessible route to the covered picnic area, due to the grass.</p> <p>A drinking fountain for standing persons is not provided.</p>

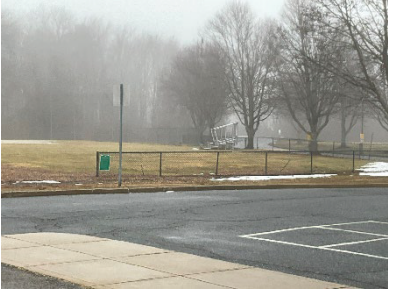
15.	<p><b>Multipurpose Sports Field</b></p> <p>The bleachers are not located on an accessible route, due to the grass.</p> <p>There is no level 30” x 48” clear floor space adjacent to the bleachers.</p>

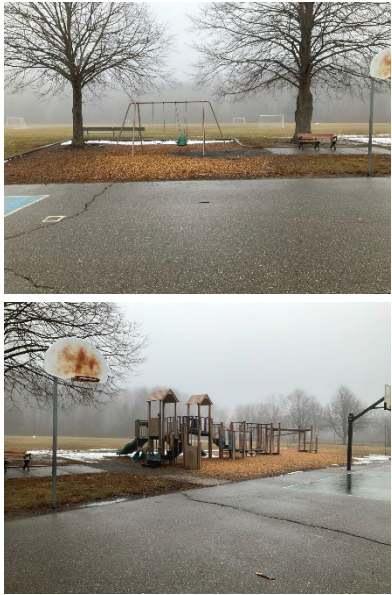
16.	<p><b>Playground Area</b></p> <p>The plaza has slopes &gt;2%, @ 2.2%.</p> <p><i>Est. Quantity: 1,800 SF</i></p> <p>The playground lacks the required number of ground-level play components and an accessible route between elements due to the woodchip surface.</p> <p>There is no accessible route to the swing set and playground due to the woodchip surfaces.</p>

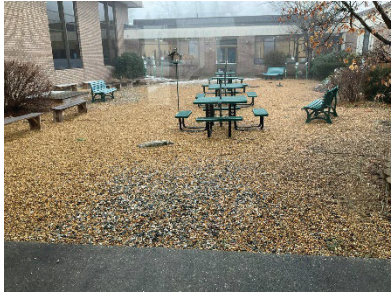
17.	<p><b>Courtyard</b></p> <p>The route to the courtyard is not stable, firm, or slip resistant due to the gravel surface.</p>

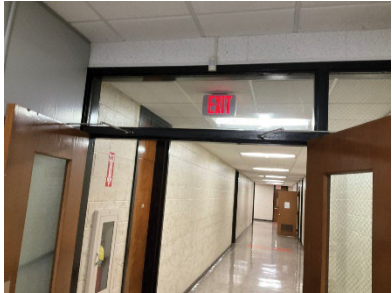
18.	<p><b>Illuminated Exit Signage (Typical)</b></p> <p>The illuminated exit signs at all accessible means of egress are not identified with the International Symbol of Accessibility (ISA).</p> <p><i>Est. Quantity: 5</i></p>

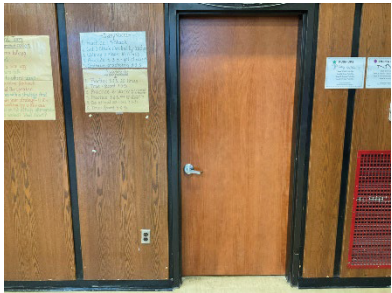
19.	<p><b>Tactile/Braille Signage (Typical)</b></p> <p>All rooms lack the required tactile/Braille signage mounted on the latch side of the door.</p> <p><i>Est. Quantity: 120</i></p>

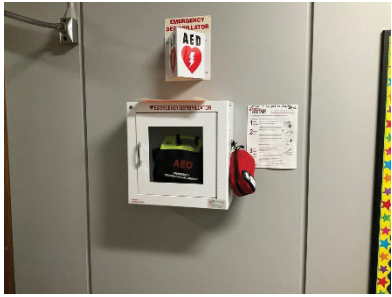
20.	<p><b>AED</b></p> <p>The AED protrudes &gt;4" into the circulation space, @ 7", and is mounted &gt;48" AFF measured to the highest operable control, @ 57".</p> <p><i>Observed in the corridor near the main entrance.</i></p>

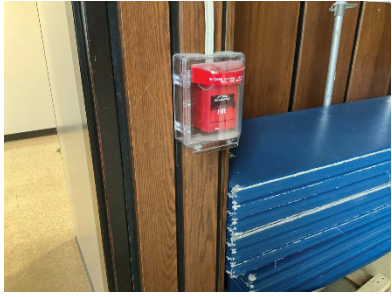
21.	<p><b>Emergency Fire Pull Station</b></p> <p>The emergency fire pull station protrudes &gt;4" into the circulation space, @ 5", due to the plastic covering.</p> <p><i>Observed in the gymnasium.</i></p>

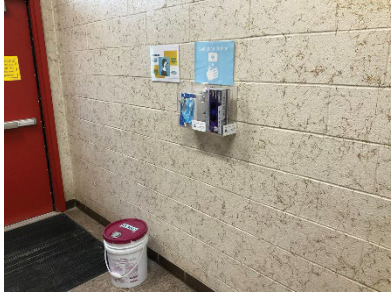
22.	<p><b>Sanitation Stations</b></p> <p>The sanitation stations protrude &gt;4" into the circulation space, @ 4 1/2".</p> <p><i>Observed in the vestibule near the Superintendent's Office and the nurse's office.</i></p> <p><i>Quantity: 2</i></p>

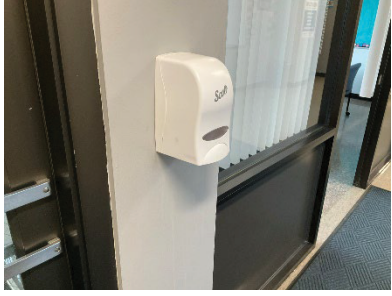
23.	<p><b>Hand Sanitizer Dispensers</b></p> <p>The hand sanitizer dispenser protrudes &gt;4" into the circulation space, @ 5 1/2".</p> <p><i>Observed throughout the building.</i></p> <p><i>Est. Quantity: 10</i></p>

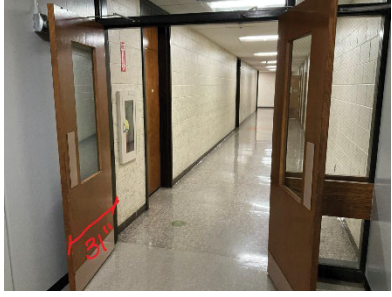
24.	<p><b>Double Doors in Corridors (Typical)</b></p> <p>The double doors lack at least one leaf that provides the required 32" minimum clearance, @ 31".</p> <p><i>Observed in all corridors throughout the building.</i></p> <p><i>Quantity: 12</i></p>

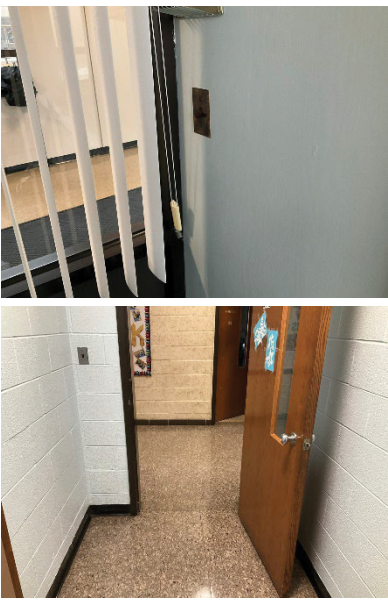
25.	<p><b>Light Switches (Typical)</b></p> <p>The light switch control is mounted &lt;18" from an interior corner, @ 4 ¼" or less.</p> <p>The light switch control is mounted &gt;48" AFF measured to the highest operable part when switched to the 'on' position, @ 49 ½".</p> <p><i>Observed throughout the building.</i></p> <p><i>Est. Quantity: 110</i></p>

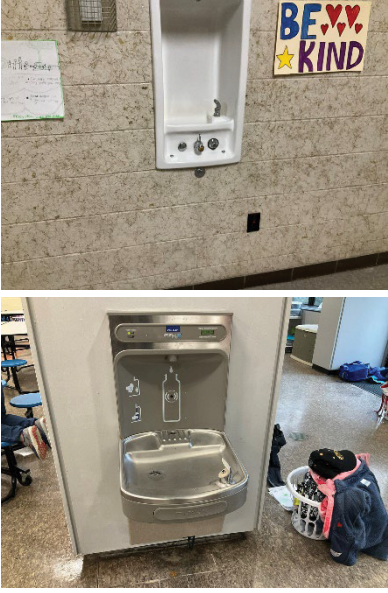
26.	<p><b>Drinking Fountains (Typical)</b></p> <p>At least 50% of the total drinking fountains provided are not for standing persons.</p> <p><i>Observed in corridors, between classrooms B111 &amp; B112, and in the cafeteria.</i></p> <p><i>Est. Quantity: 5</i></p> <p>The drinking fountains for seated persons lack the required knee clearance for a forward approach.</p> <p><i>Observed in corridors and between B111 &amp; B112.</i></p> <p><i>Est. Quantity: 10</i></p> <p>The knee clearance at the cafeteria drinking fountain is &lt;27" AFF, @ 24 ½".</p> <p><i>Note: ADA 602.2 Exception permits a parallel approach for drinking fountains primarily used by children when the spout is 30" AFF maximum. However, 521 CMR does not distinguish between adult and children's dimensions for drinking fountains.</i></p>

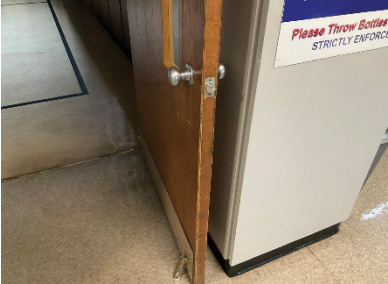
27.	<p><b>Door Hardware (Typical)</b></p> <p>The door hardware requires tight grasping, pinching, and/or twisting of the wrist to operate.</p> <p><i>Observed throughout the building.</i></p> <p><i>Est. Quantity: 90</i></p>

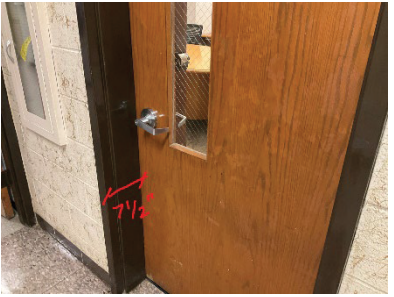
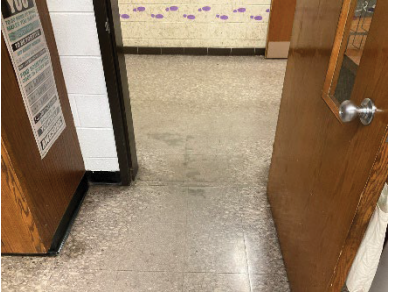
28.	<p><b>Door Maneuvering Clearances (Typical)</b></p> <p>Some doors with both latch and closers are located in recesses &gt;6" deep, @ 7 ½", and do not provide the required push side maneuvering clearance.</p> <p><i>Observed in some admin areas and offices.</i></p> <p><i>Est. Quantity: 6</i></p> <p>Most doors lack the required 18" minimum pull side maneuvering clearance, @ 2"-17".</p> <p><i>Observed in most classrooms, the nurse's office, admin areas, faculty lounge, library, and music room.</i></p> <p><i>Est. Quantity: 30</i></p>

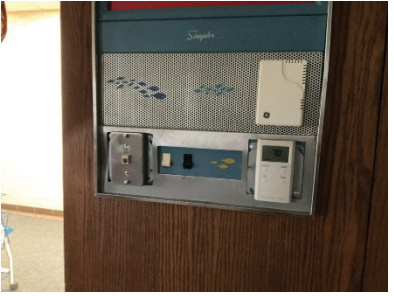
29.	<p><b>Classroom Intercoms (Typical)</b></p> <p>The intercom controls are &gt;48" AFF, @ 50"-58 ½".</p> <p><i>Observed in all classrooms.</i></p> <p><i>Quantity: 21</i></p>

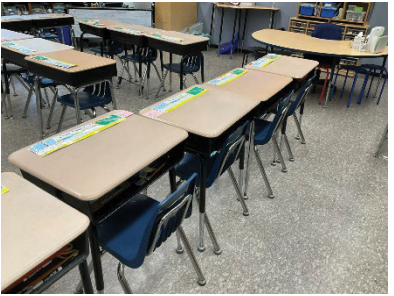
30.	<p><b>Classroom Desks (Typical)</b></p> <p>Some of the children's desks lack the required 25" AFF minimum knee/toe clearance, @ 22", and are &lt;30" wide, @ 18".</p> <p><i>Observed in most classrooms.</i></p> <p><i>Est. Quantity: 12</i></p>

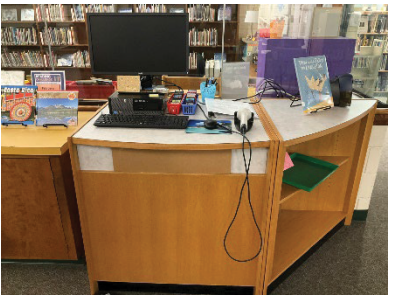
31.	<p><b>Library Computer Station</b></p> <p>The computer station lacks the required knee/toe clearance for a forward approach and is &gt;34" AFF, @ 37 ¾".</p>

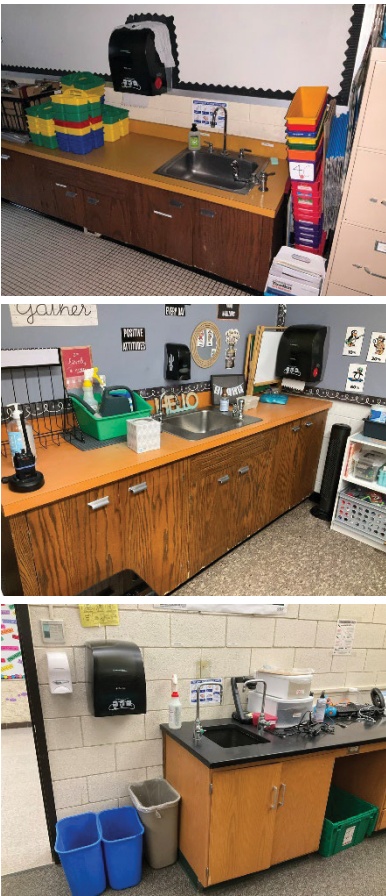
<p>32.</p>	<p><b>Classroom Sinks &amp; Bubblers (Typical)</b></p> <p>The sink lacks the required knee and toe clearance for a forward approach due to the cabinetry.</p> <p>The drinking fountain lacks the required knee and toe clearance for a forward approach due to the cabinetry, and some spouts are &gt;30" AFF, @ 40".</p> <p><i>Observed in all classrooms and the library.</i></p> <p><i>Quantity: 22</i></p> <p>Some sinks are &gt;34" AFF, @ 36 ¼".</p> <p><i>Observed in Classrooms A100 &amp; B112, and the library.</i></p> <p><i>Quantity: 3</i></p> <p><i>Note: ADA 606.2 Exception 4 permits children's sinks to provide 24" AFF minimum knee clearance and Exception 5 permits a parallel approach for sinks primarily used by children 5 years and younger. Similarly, ADA 602.2 Exception permits a parallel approach for drinking fountains primarily used by children when the spout is 30" AFF maximum. However, 521 CMR does not distinguish between adult and children's dimensions for classroom sinks nor drinking fountains.</i></p>

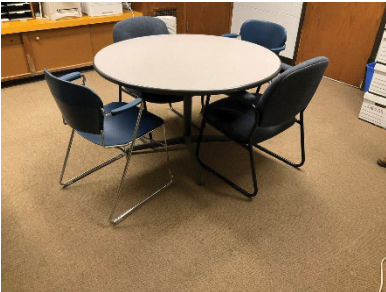
<p>34.</p>	<p><b>Admin Areas near Superintendent's Office</b></p> <p>The tables lack the required knee/toe clearance due to the pedestal below.</p> <p><i>Quantity: 2</i></p>

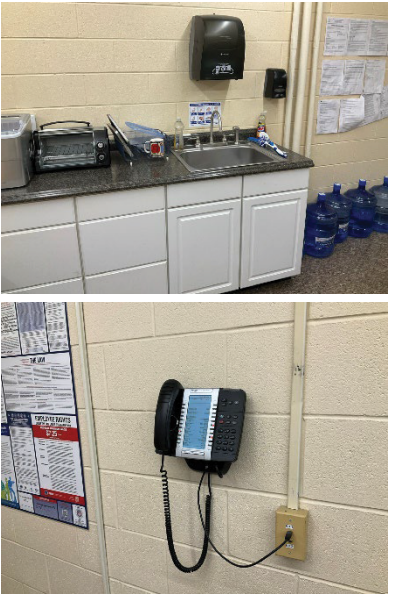
35.	<p><b>Staff Lounge near Cafeteria</b></p> <p>The sink is &gt;34" AFF, @ 36".</p> <p>The paper towel and soap dispensers are mounted &gt;46" AFF for an obstructed side reach measured to the highest operable control, @ 49" and 54 ½".</p> <p><i>Quantity: 2</i></p> <p>The phone controls are mounted &gt;48" AFF measured to the highest operable control, @ 58".</p>

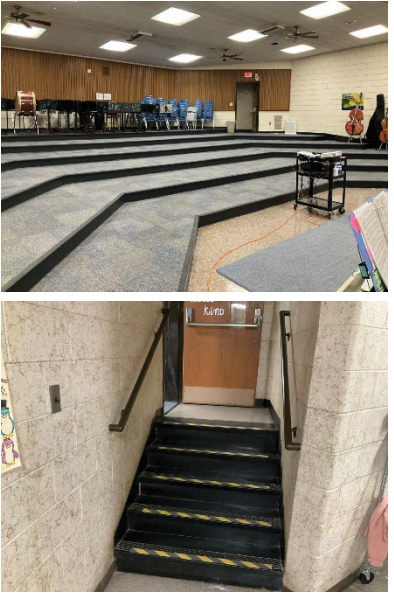
36.	<p><b>Music Room</b></p> <p>Two of the music room doors are not on an accessible route, due to the stairs.</p> <p>Two accessible means of egress are not provided in the room where more than two egress doors are provided.</p> <p>The stair handrails lack the required extensions.</p> <p>There is no accessible route to the seating area due to the risers.</p>

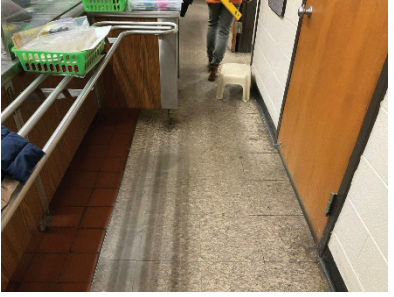
37.	<p><b>Cafeteria Servery</b></p> <p>The servery doors lack the required pull side maneuvering clearance depth, @ 37 ½".</p> <p><i>Quantity: 4</i></p> <p>The accessible route through the servery lacks the required 48" minimum turning clearance, @ 37 ½" measured from the wall to the tray slide.</p> <p><i>Quantity: 2</i></p>

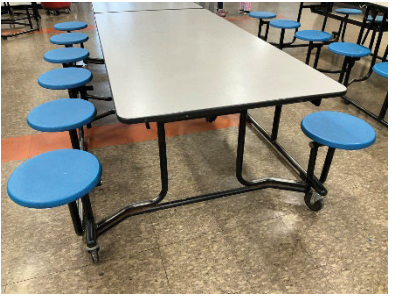
38.	<p><b>Cafeteria Seating</b></p> <p>The tables lack the required 19" minimum knee/ toe clearance depth, @ 14 ½".</p>

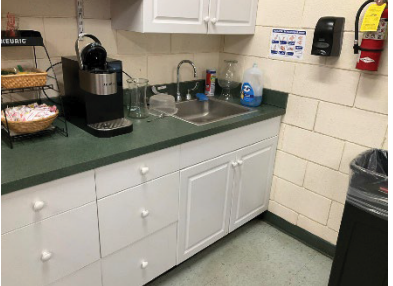
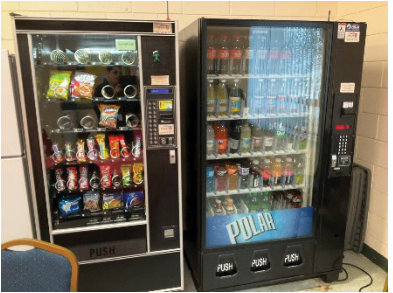
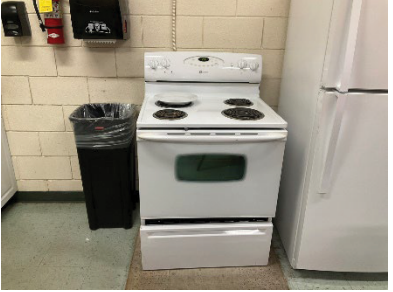
39.	<p><b>Teacher's Lounge</b></p> <p>The sink is &gt;34" AFF, @ 36", and lacks the required knee clearance for a forward approach.</p> <p>The paper towel and soap dispensers are mounted &gt;48" AFF measured to the highest operable control, @ 51".</p> <p><i>Quantity: 2</i></p> <p>The vending machine controls are &gt;48" AFF measured to the highest operable control, @ 55".</p> <p><i>Quantity: 2</i></p> <p>The oven controls are mounted behind the burners.</p>

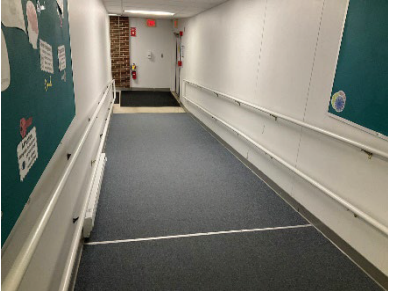
40.	<p><b>Ramp to Modular Classrooms</b></p> <p>The ramp has running slopes &gt;8.3%, @ 8.6%-9.1%.</p>

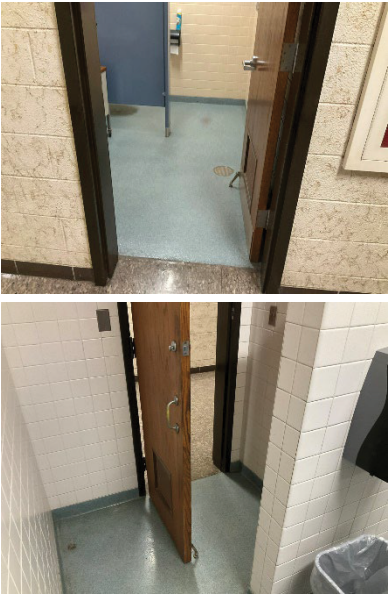
<p>41.</p>	<p><b>Toilet Room Doors (Typical)</b></p> <p>The door provides &lt;32" of clear width, @ 21"-30".  <i>Observed in all student and staff toilet rooms.</i>  <i>Quantity: 16</i></p> <p>The pull side door maneuvering clearance is &lt;60" deep, @ 42"-48", and &lt;18" on the latch side, @ 5 ½".  <i>Observed in all girls' &amp; boys' multiuser toilet rooms.</i>  <i>Quantity: 6</i></p>

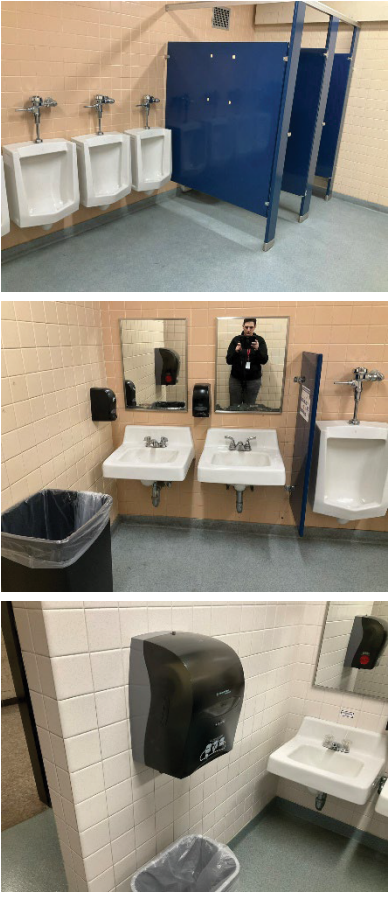
<p>42.</p>	<p><b>Girls' &amp; Boys' Multiuser Toilet Rooms (Typical)</b></p> <p>There is no accessible toilet stall provided.</p> <p>For a toilet room with six or more toilets/ urinals, there is no ambulatory stall provided.</p> <p>The paper towel dispenser protrudes &gt;4" into the circulation space, @ 9".</p> <p>The mirror is mounted &gt;31" AFF measured to the bottom of the reflective surface, @ 37 ½".</p> <p>The knee clearance at the sink is &lt;25" AFF, @ 17".</p> <p>The pipes underneath the sink are not insulated.</p> <p>The sink faucet requires tight grasping, pinching, and/or twisting of the wrist to operate.</p> <p><i>Observed in all girls' and boys' multiuser toilet rooms, except one near Classroom A111.</i>  <i>Quantity: 5</i></p> <p><i>Note: These toilet rooms appear to be utilized by students in Grades 4-5, therefore KMA audited based on the relevant children's dimensional requirements. KMA has received guidance from the MAAB stating that these toilet rooms must meet either adult dimensions or the dimensions for the user group with the highest population using these facilities.</i></p>

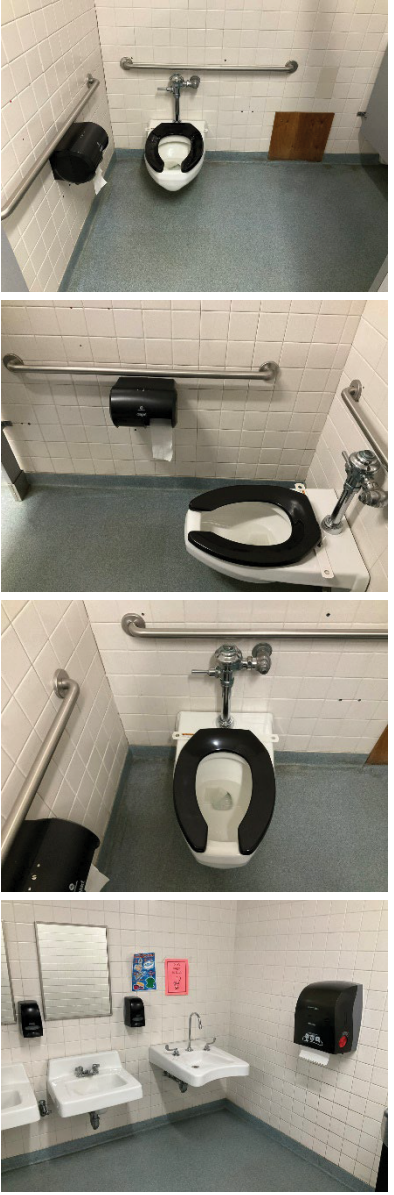
<p>43.</p>	<p><b>Girls' Multiuser Toilet Room near Classroom A111</b></p> <p>The paper towel dispenser protrudes &gt;4" into the circulation space, @ 9".</p> <p>The pipes underneath the sink are not insulated.</p> <p>The soap dispenser is &gt;36" AFF, @ 38".</p> <p>The mirror is mounted &gt;31" AFF measured to the bottom of the reflective surface, @ 40 ¾". <i>Note: There is no mirror provided at the designated accessible sink.</i></p> <p>The coat hook is &gt;48" AFF, @ 52".</p> <p>The flush control is not located on the open side of the toilet.</p> <p>The toilet centerline is not located 15"-18" from the adjacent wall, @ 19".</p> <p>The toilet seat height is not 15"-17" AFF, @ 14 ½".</p> <p>The toilet paper dispenser is not located 7"-9" from the rim, @ 5 ½".</p> <p>The toilet paper dispenser is mounted &lt;1 ½" below the side grab bar, @ 1 ¼".</p> <p>The toilet flush valve is &lt;1 ½" below the rear grab bar, @ ½".</p> <p>The trash receptacle in the accessible toilet stall is &gt;36" AFF, @ 52 ½".</p> <p>The grab bars are not 25"-27" AFF, @ 30".</p> <p><i>Note: This toilet room appears to be utilized by students in Grades 4-5, therefore KMA audited based on the relevant children's dimensional requirements. KMA has received guidance from the MAAB stating that these toilet rooms must meet either adult dimensions or the dimensions for the user group with the highest population using these facilities.</i></p>

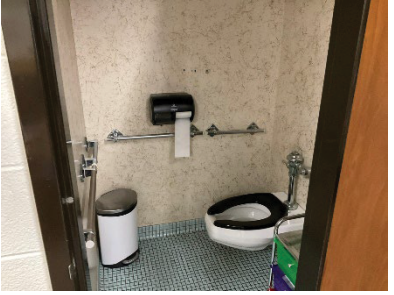
<p>44.</p>	<p><b>Toilet Room in Nurse's Office</b></p> <p>The room lacks the required footprint and elements for an accessible toilet room.</p>

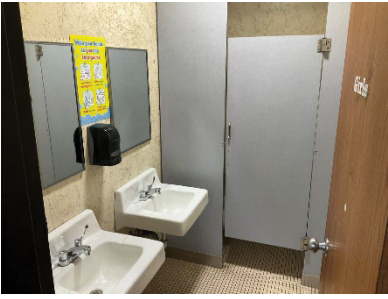
45.	<p><b>Toilet Rooms in Classrooms B111, B112, &amp; D110</b></p> <p>The room lacks the required footprint and elements for an accessible toilet room.</p> <p><i>Quantity: 3</i></p>

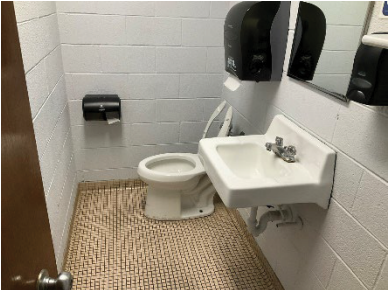
46.	<p><b>Staff Toilet Rooms (Typical)</b></p> <p>The room lacks the required footprint and elements for an accessible toilet room.</p> <p><i>Observed in corridors and the facilities and kitchen staff areas.</i></p> <p><i>Quantity: 6</i></p>

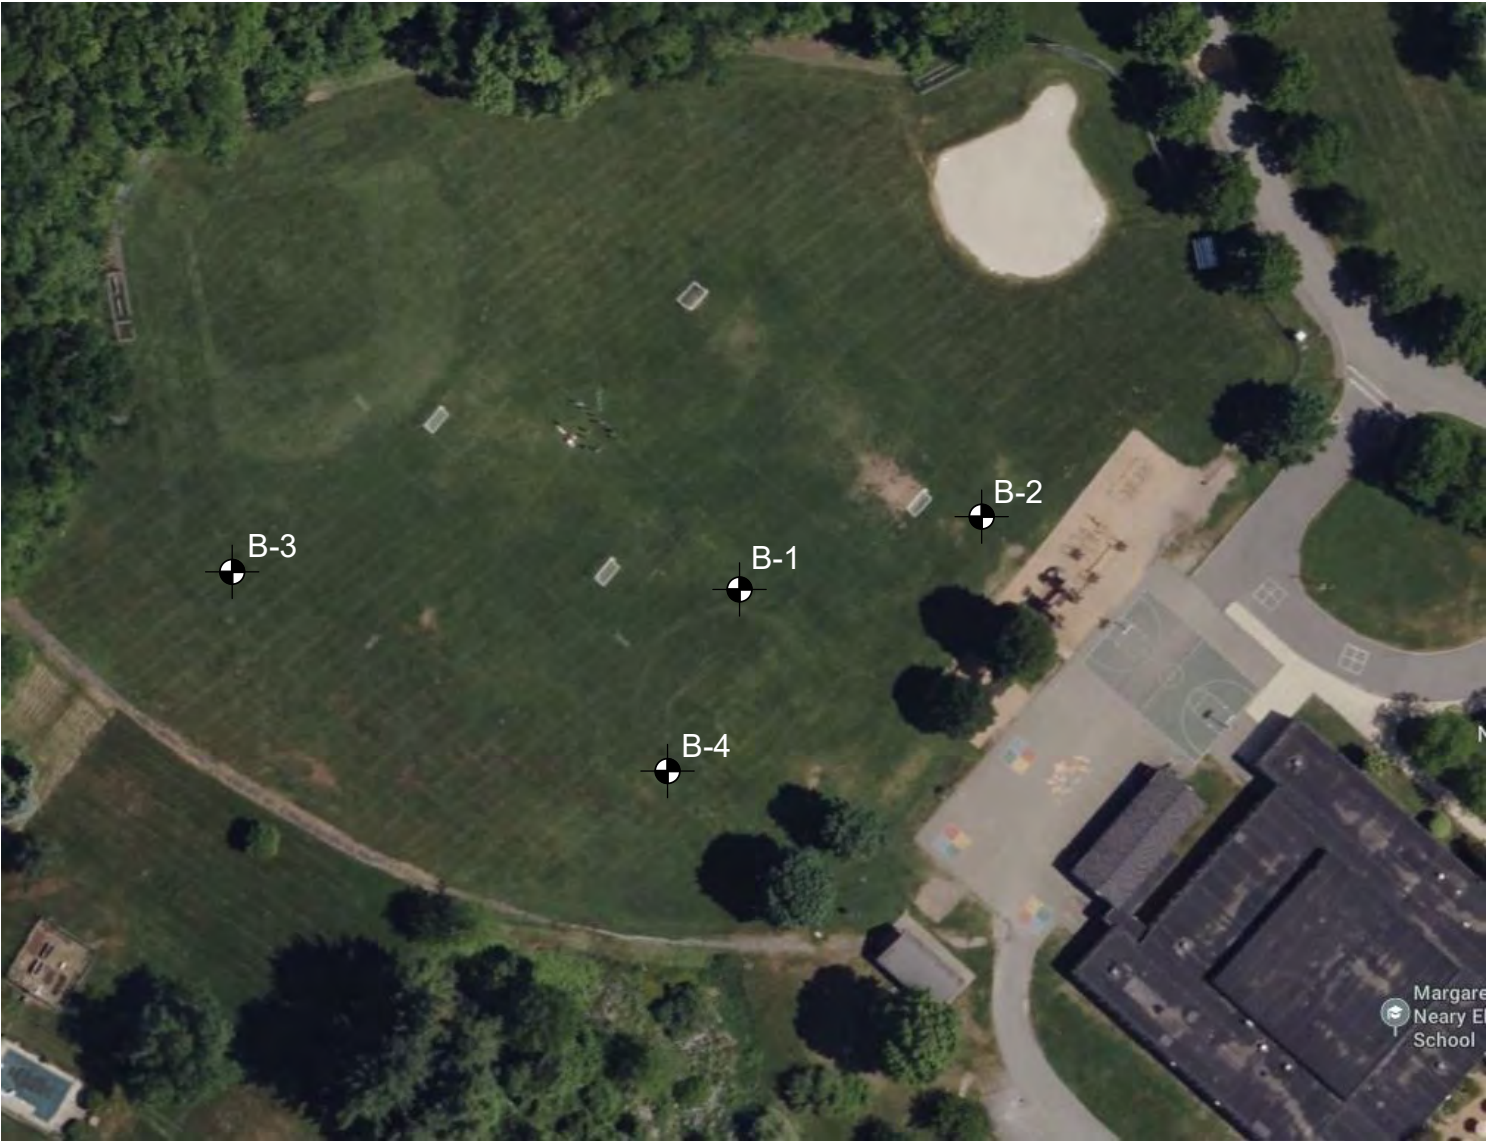
Client:  Arrowstreet		Project:  Proposed Neary Elementary School		Figure 3 – Boring Location Plan

Approximate location of borings advanced by Soil X Corporation of Leominster, MA on April 15, 2024, and observed by Lahlaf Geotechnical Consulting, Inc. (LGCI).

The boring locations are shown in Figure 3. Appendix A contains LGCI's boring logs and Table 1 includes a summary of LGCI's borings.
