# Evaluation of Southborough Sites

# Existing Conditions Report

# Structural Conditions

## INTRODUCTION

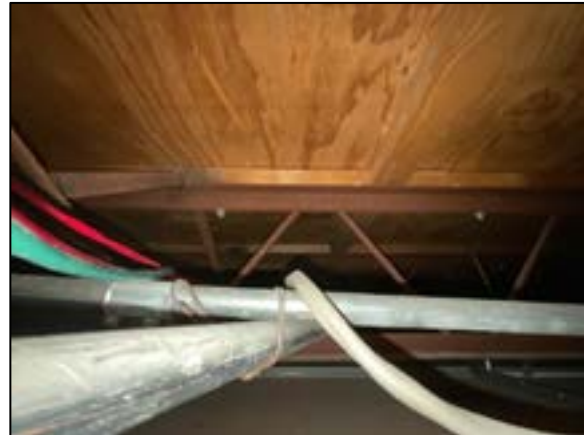
FIGURE 3: PLYWOOD ROOF AND STEEL STRUCTURE

The 1968 original drawings indicate that the building is constructed with masonry exterior walls and steel framing, which is consistent with what was observed on site. Corridors are generally constructed with CMU throughout. Combustible construction was observed in small MEP spaces and the 1968 drawings indicate plywood at select locations. A small modular structure constructed as an addition consists of masonry exterior walls and noncombustible structure. A building separation was not observed between the existing building and the modular addition. The construction type of the building defaults to **Type IIIB** construction due to the combustible construction. However, if the wood construction is removed, the building would be permitted to be classified as **Type IIB** construction under the current edition of 780 CMR.

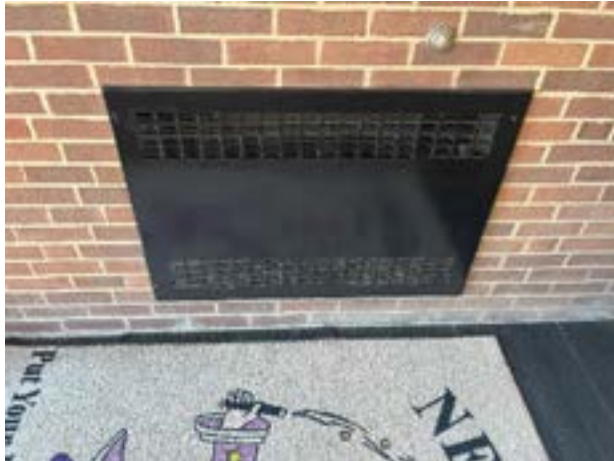
Entryways, hallways, storage areas, and toilet rooms are typically heated by cabinet unit heaters, convectors, or HHW fin-tube radiators.

*Typical Hot Water Convactor*

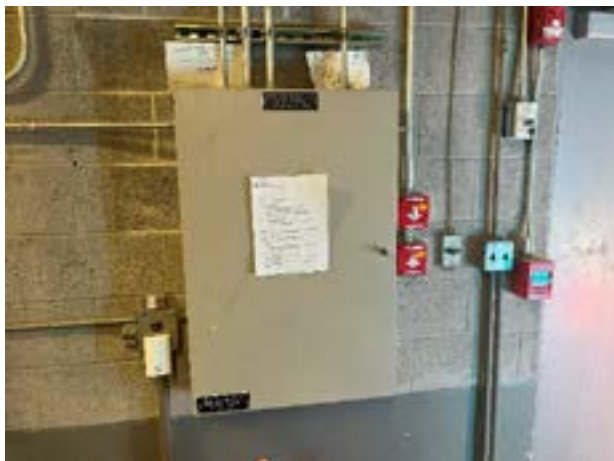
The building pneumatic control system has been replaced in favor of a standalone direct digital control system consisting of control panels, sensors/thermostats, and wiring. The control system appears to be operating to its designed capability. However, several additional renovations have subdivided spaces requiring auxiliary systems for temperature control. Further, there is no central building management system (BMS) to monitor overall building operations and assist in troubleshooting HVAC related issues.

*HHW Plant Control Panel*

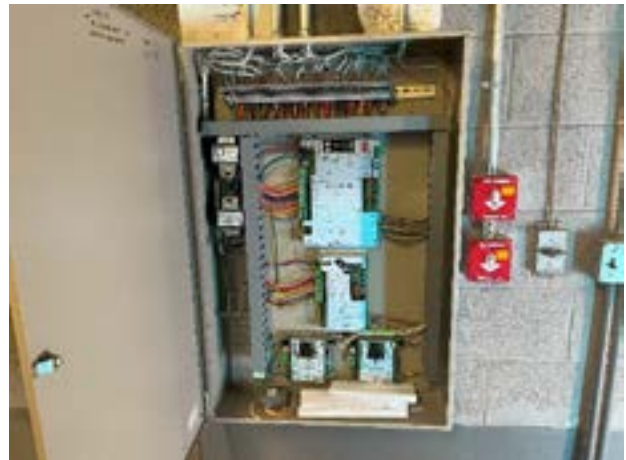
*Controllers within Control Cabinet*

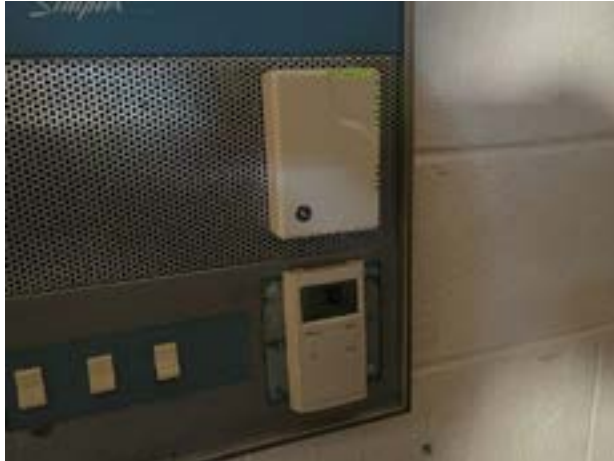
*Typical Room DDC Sensors*

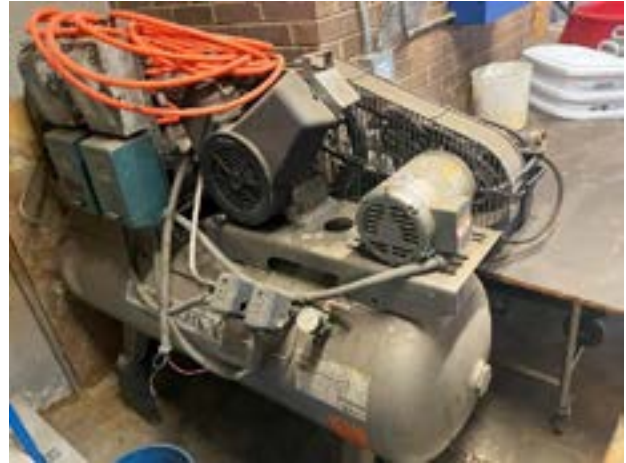
*Abandoned Pneumatic Control Compressor*

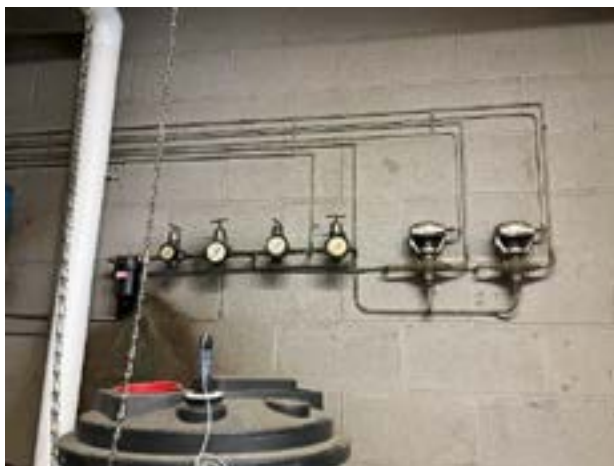
*Abandoned Pneumatic Control System Gauges*

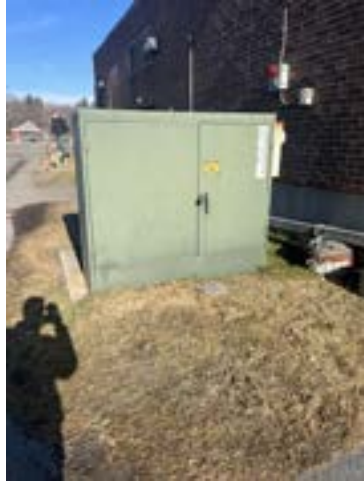
*Pad Mounted Transformer*

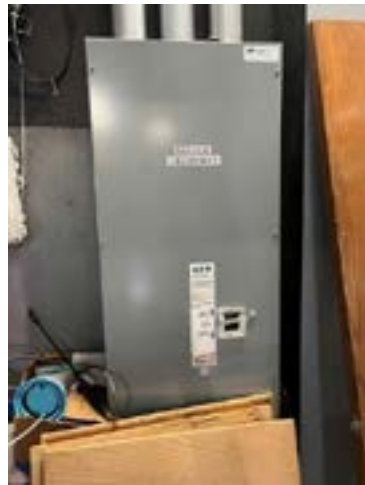
The secondary service of the building consists of a 1200A, 120/208V, 3-Phase, 4 Wire with the main serviced disconnect located within the boiler room. The main service breaker then serves the main distribution panel "MDP-A and "MDP-B" in the main electric room. The main service is sized for approximately 6.6W/SF. The majority of the electrical distribution system was upgraded in 2011, is manufacturer by Eaton and is of the circuit breaker type. The equipment is in good condition. There are some original vintage branch circuit panelboards still in operation.

*Main Service Disconnect*

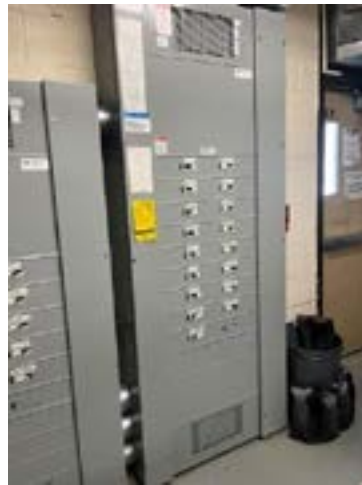
*"MDP" Main Distribution Panel*

1. Main Distribution Panel “MDP” and all 2011 vintage sub-panels are in good condition, however the capacity at 6.6W/SF is inadequate for a substantial renovation. Therefore a new primary service, and new secondary service should be provided. The service will be sized to 15W/SF at 277/480V (for all-electric HVAC system) the 2011 equipment can be backfed and re-used. Replace the entire electrical distribution system with new, Existing branch circuits to connect to new panels in areas of minor renovation.

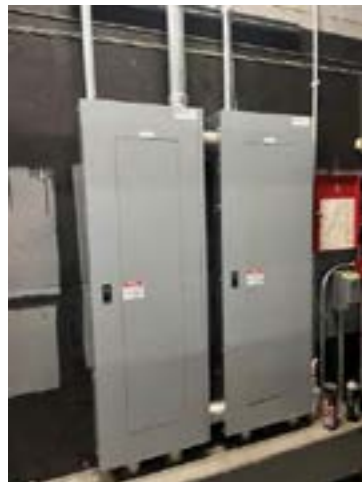
*2011 Vintage Mechanical Panelboards*

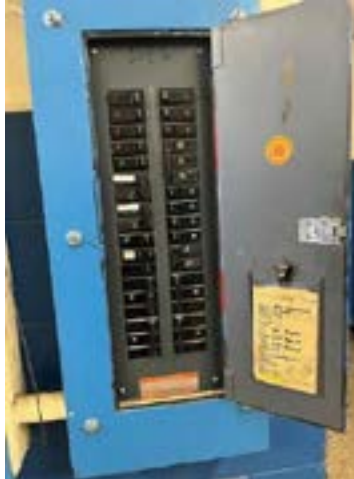
*Original Vintage Panelboard*

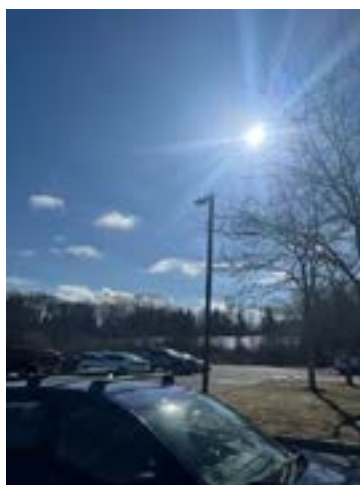
Exterior lighting consists of utility pole mounted LED fixtures with integral control

*Site Area Light Fixture*

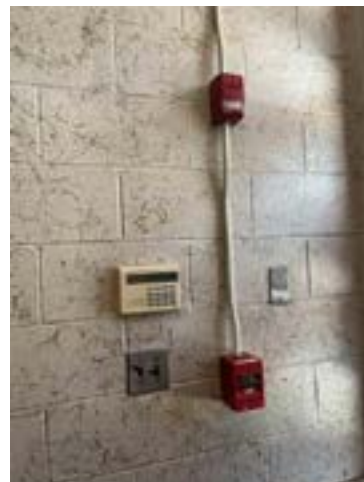
*Pull Station/Horn Strobes*

The system consists of original pull stations and horn/strobes, smoke and heat detectors.

8. A system of new automatic transfer switches and panelboards should be provided (if an electric HVAC system option is selected).
9. The existing fire alarm system is non-code compliant and should be replaced with new addressable system with voice evacuation in compliance with code.

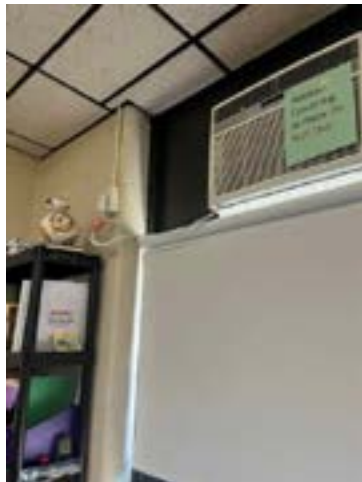
*Receptacle for Window A/C*

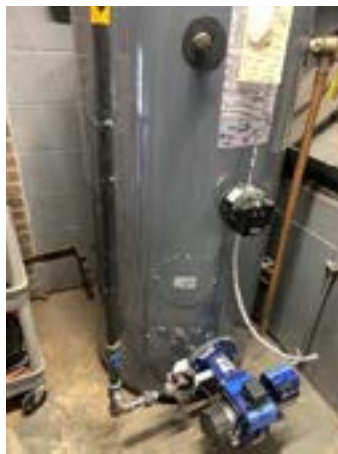
Domestic hot water for the Kitchen areas is generated through a gas-fired, tank type water heater. The water heater has a gas input of 200,000 BTU/HR and the capacity of the water heater is 67 gallons. There are multiple electric tank type water heaters located near the Toilet core areas, each with a power input of 2,000 watts and a storage capacity of 20 gallons.

*Gas Water Heater*

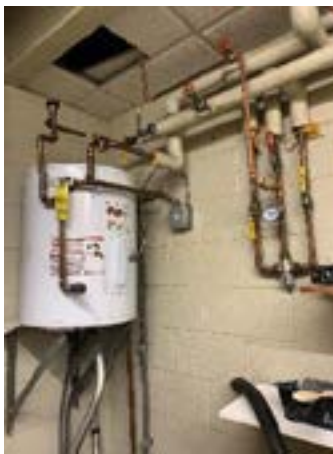
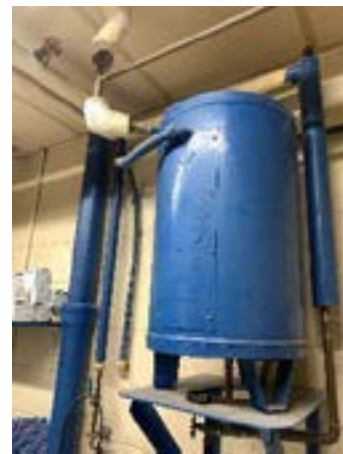
*Electric Water Heater*

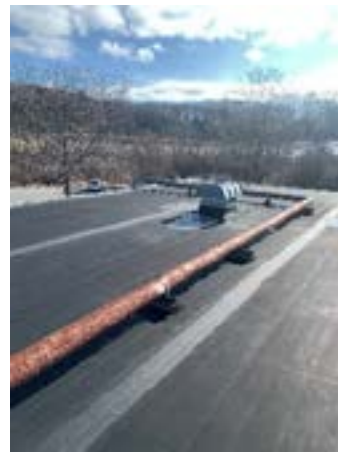
*Gas on Roof*

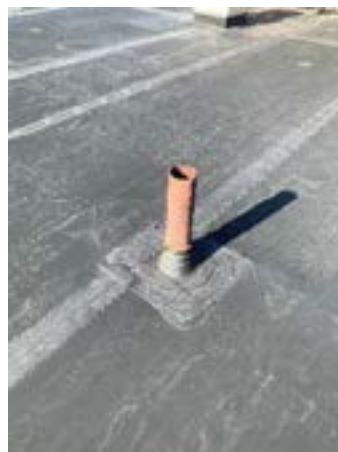
*Vent Through Roof*
