Neary Elementary School
53 Parkerville Road
Southborough, Massachusetts 01772

Facility Condition Assessment

April 2, 2021

Re: Facility Condition Assessment
Neary Elementary School
53 Parkerville Road
Southborough, Massachusetts 01772
VERTEX Project No. 69604

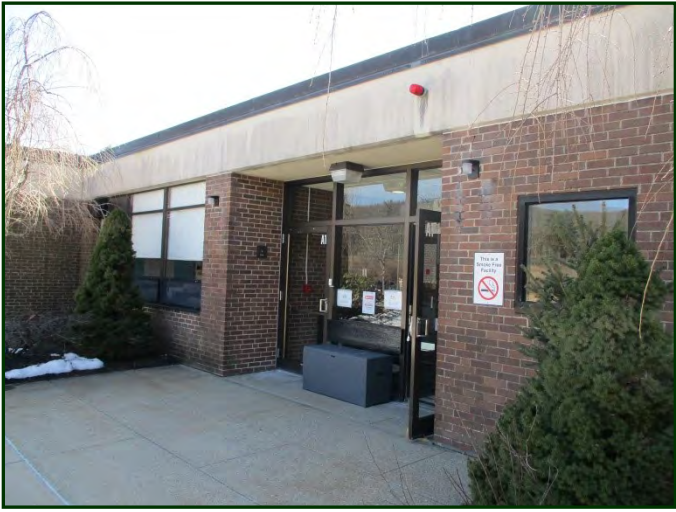
Photo #2: Main building entrance

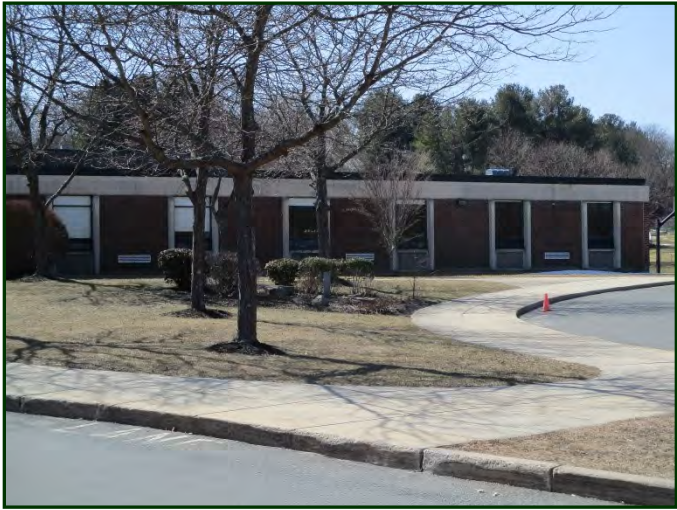
Photo #3: Partial east elevation

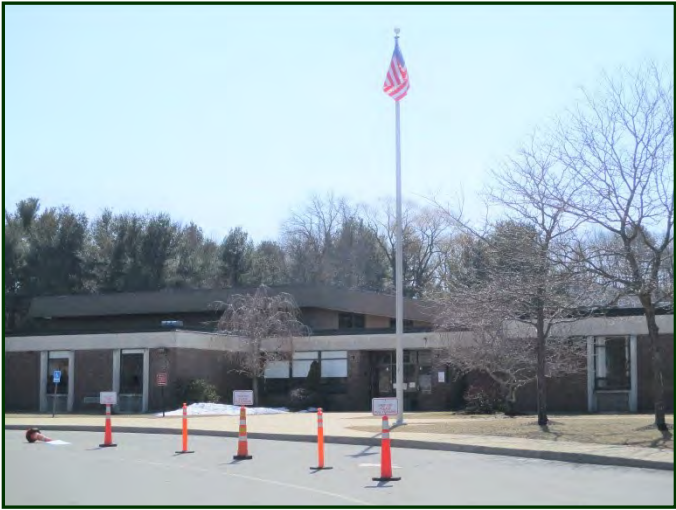
Photo #4: Drop-off/pick-up at main entrance (east elevation)

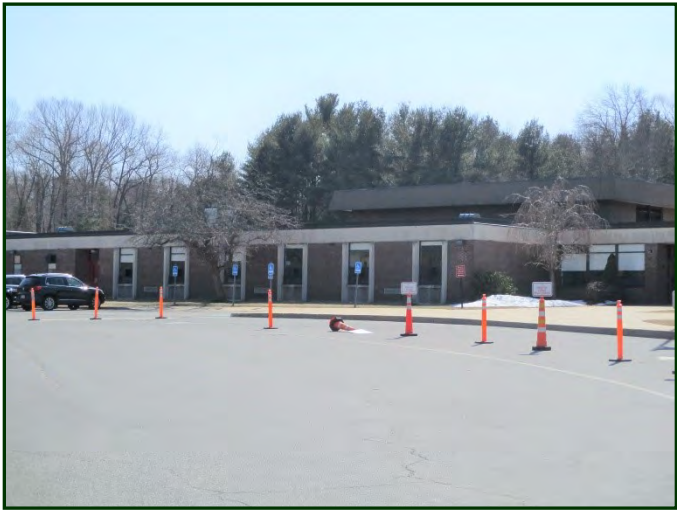
Photo #5: Partial east elevation

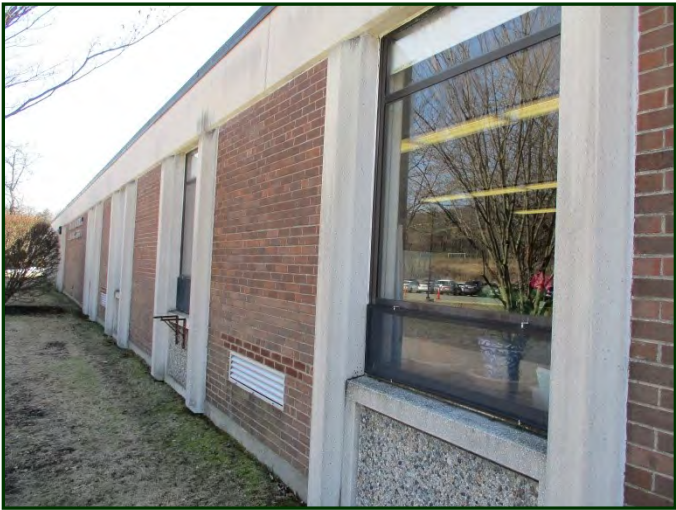
Photo #6: Close-up view of aluminum-framed windows, cast stone trim, brick veneer & thru-wall ventilation

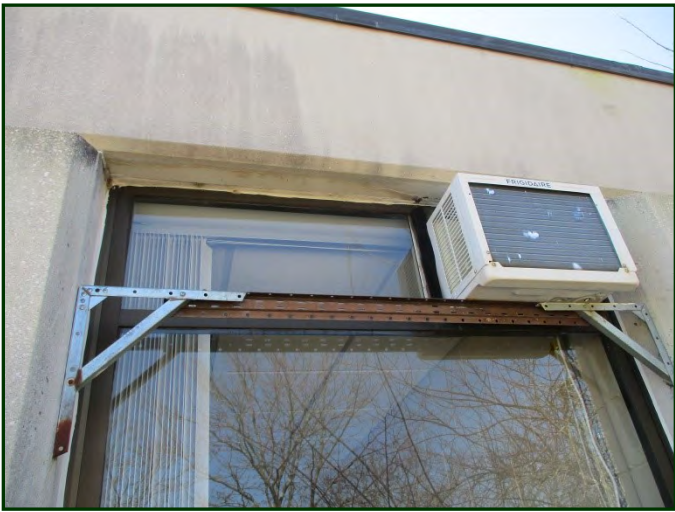
Photo #8: Through-window mounted air conditioning unit

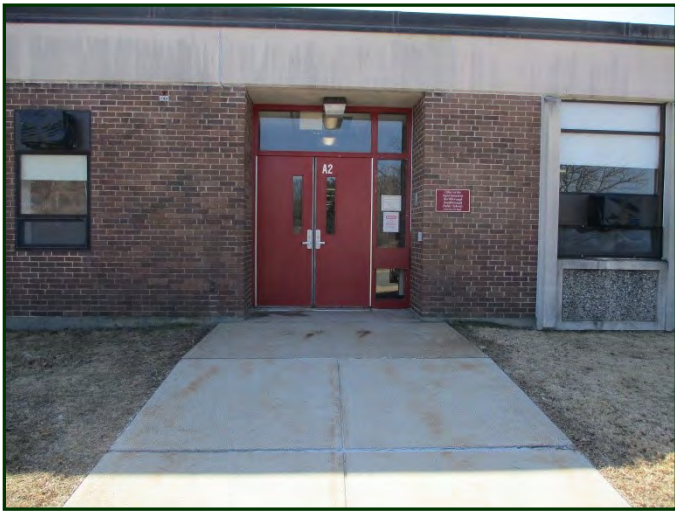
Photo #9: Secondary entrance at the Office of the Superintendent Northborough Southborough Public Schools

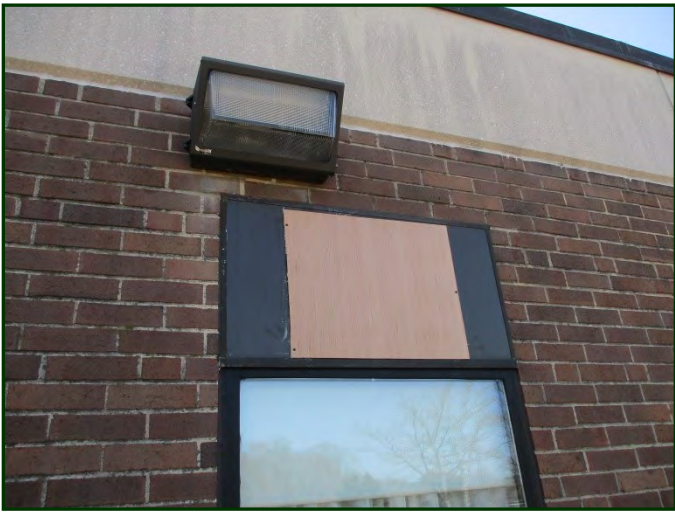
Photo #10: View of wall-mounted light fixture & blank off panel infilled with wood paneling (prior opening for AC unit)

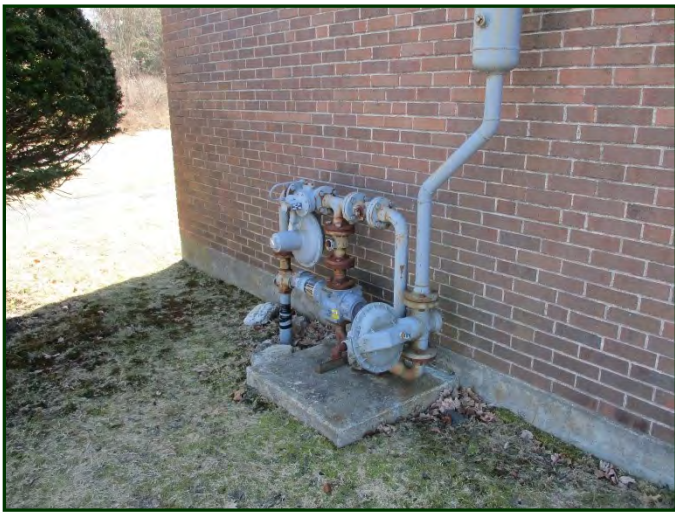
Photo #11: Natural gas service at southeast corner of building

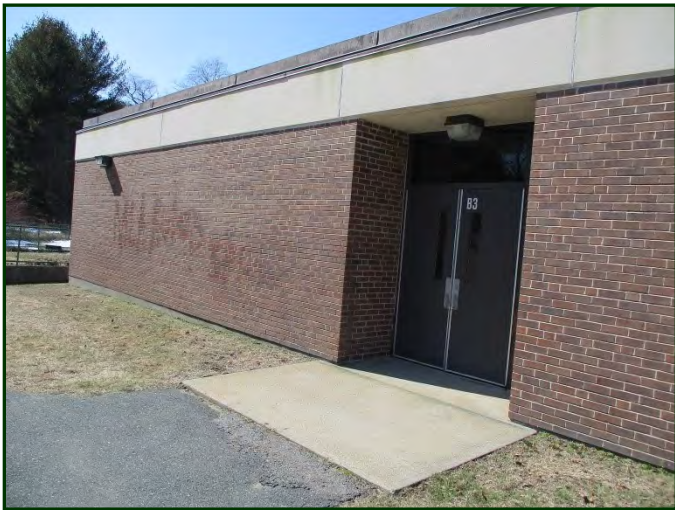
Photo #13: Egress doors at south elevation with soffit-mounted light fixture

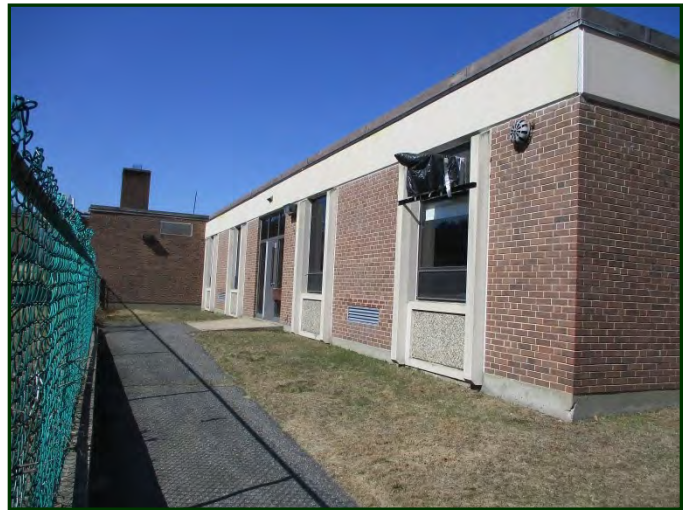
Photo #14: Partial west elevation. Note asphalt sidewalk

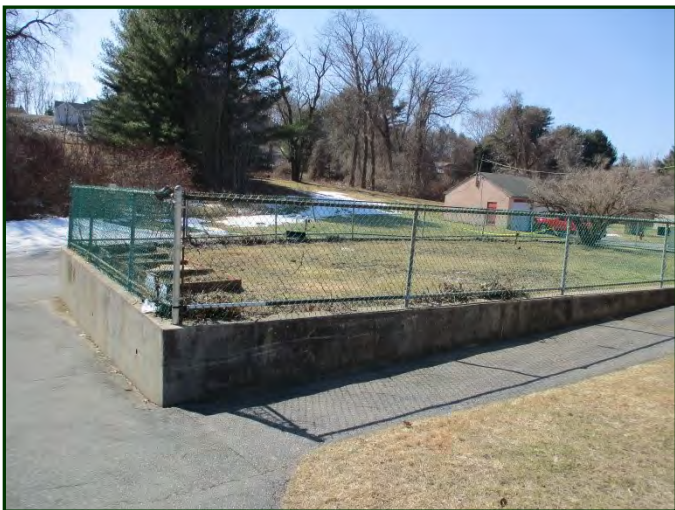
Photo #15: Raised area of lawn at the southwest corner with concrete retaining wall and chain link fencing

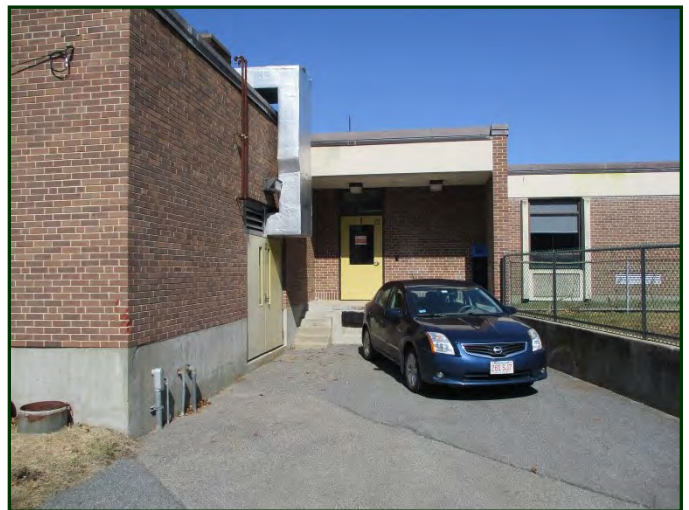
Photo #16: Concrete loading dock with bumpers at west elevation (rear of building). Note ductwork from roof to boiler room

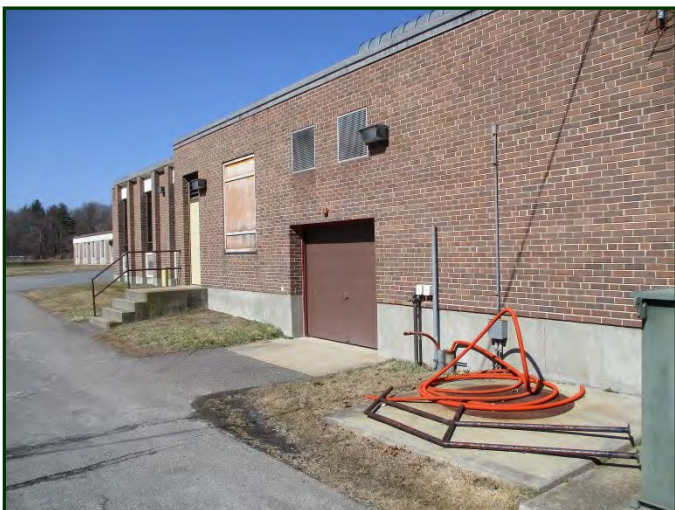
Photo #17: West elevation with overhead door & concrete stairs

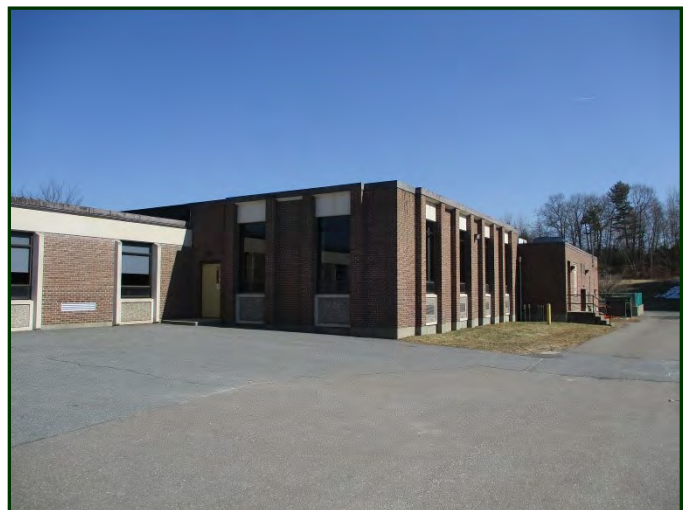
Photo #18: Transition from higher roof with taller windows at the Cafeteria

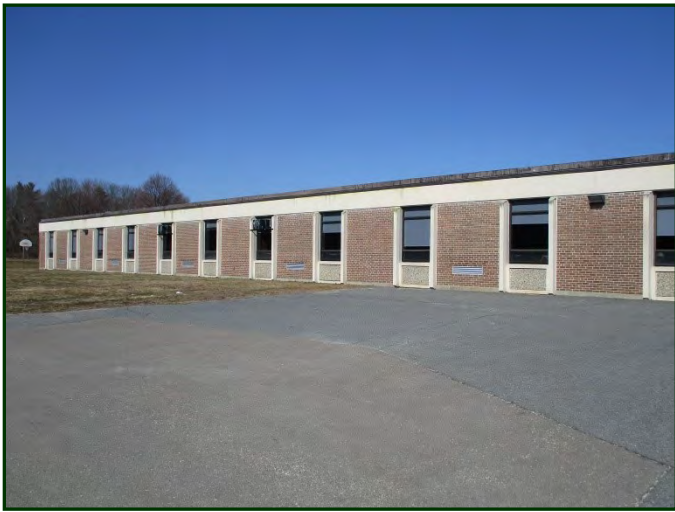
Photo #19: Partial west elevation. Note asphalt paving

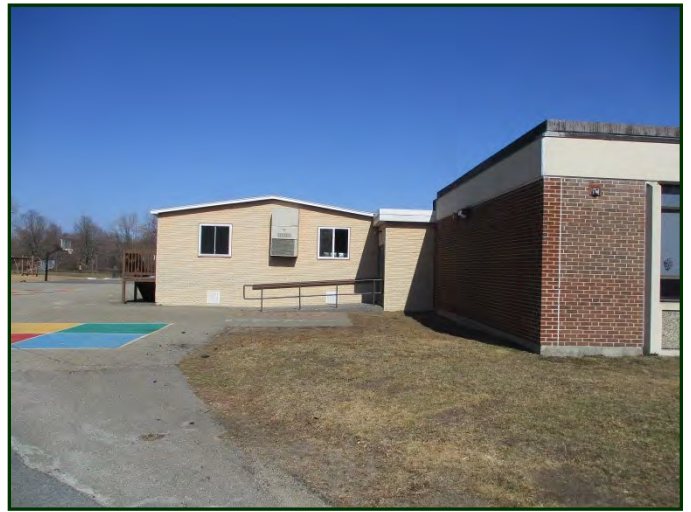
Photo #20: North side of building with modular classrooms

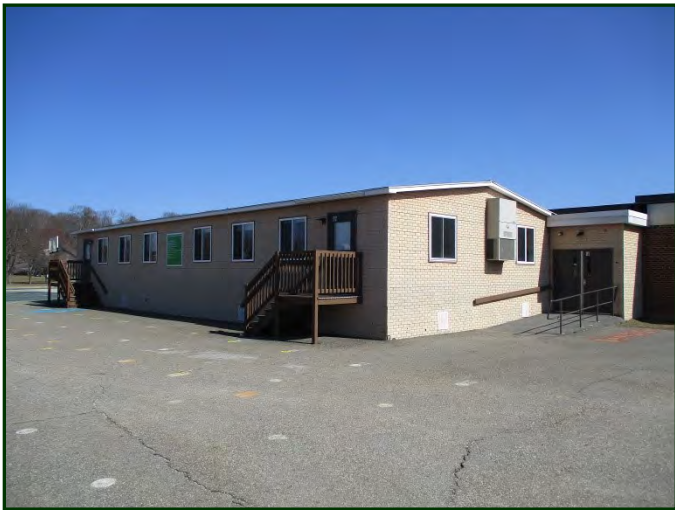
Photo #21: Modular classrooms. Note wood stairs & asphalt ramp with railings

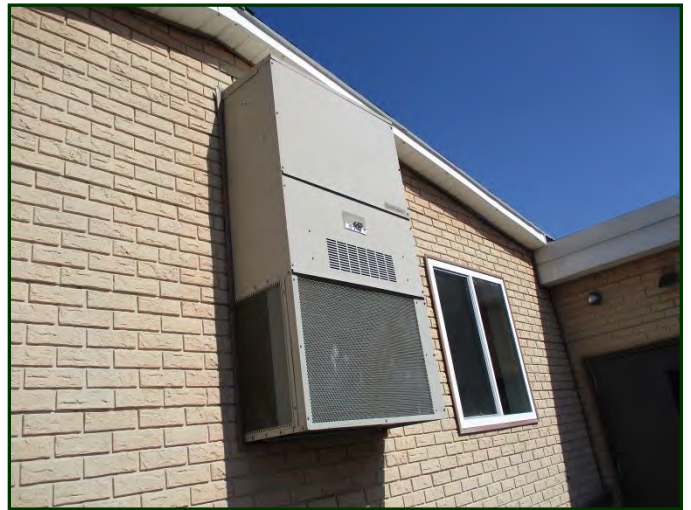
Photo #22: View of wall-mounted air handling unit & (faux brick) vinyl siding & vinyl-framed sliding windows

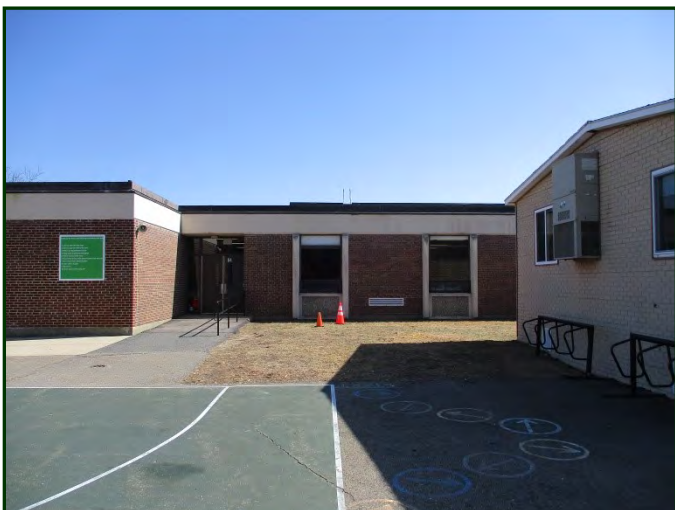
Photo #23: Partial north elevation

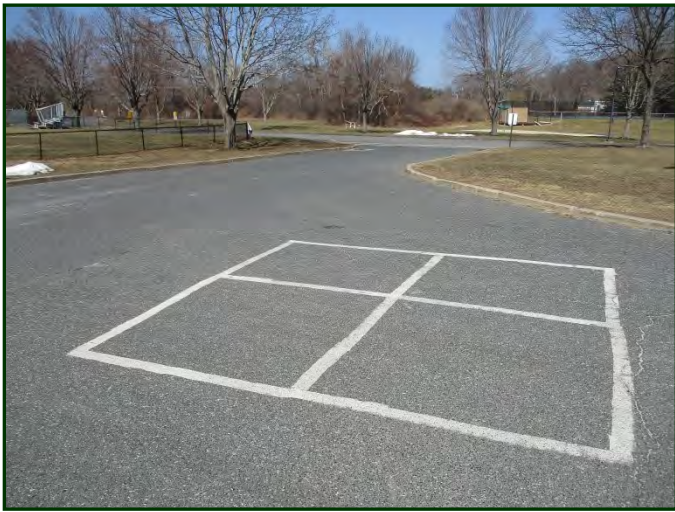
Photo #25: Overview of asphalt paving with concrete curbing at north side

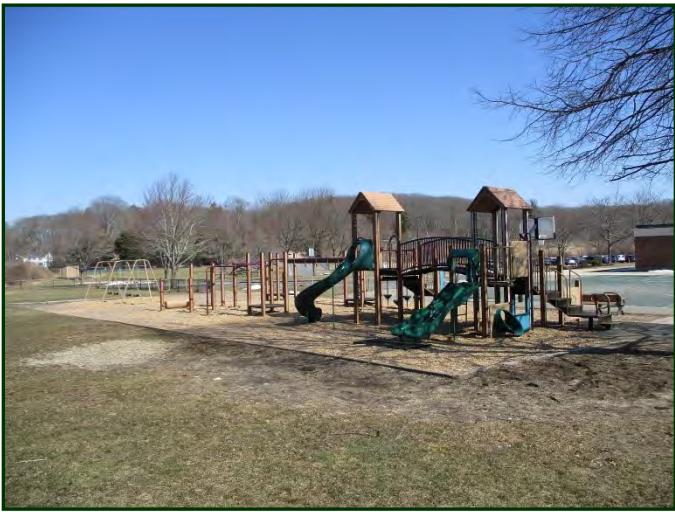
Photo #26: Playground equipment (steel & polycarbonate-type) with wood chips & wood curbing at north side of site

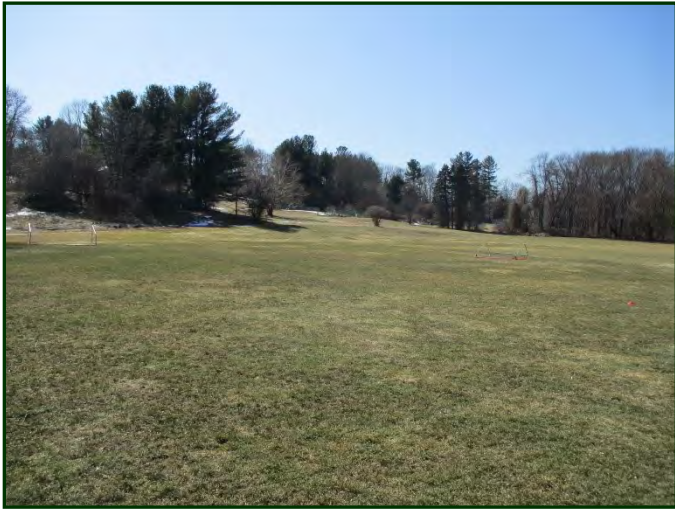
Photo #27: Playing fields on north side of site

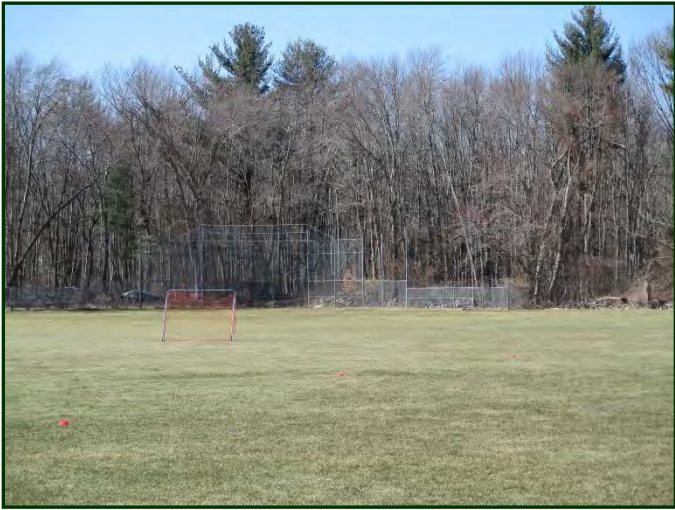
Photo #28: Playing fields on north side of site

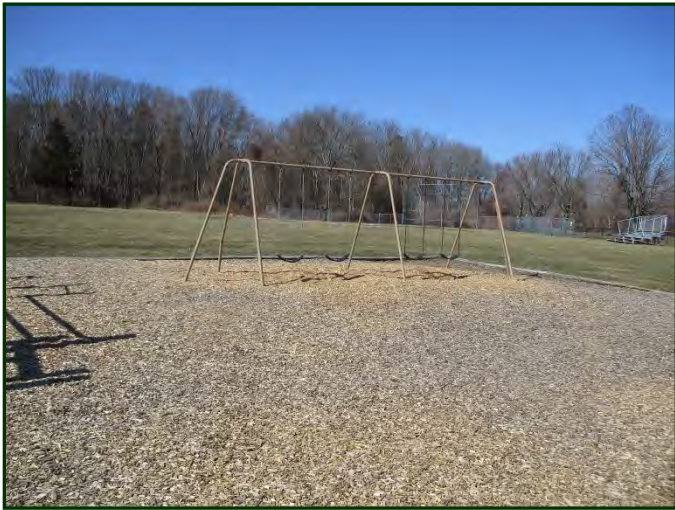
Photo #29: Playground equipment (steel & polycarbonate-type) with wood chips & wood curbing at north side of site

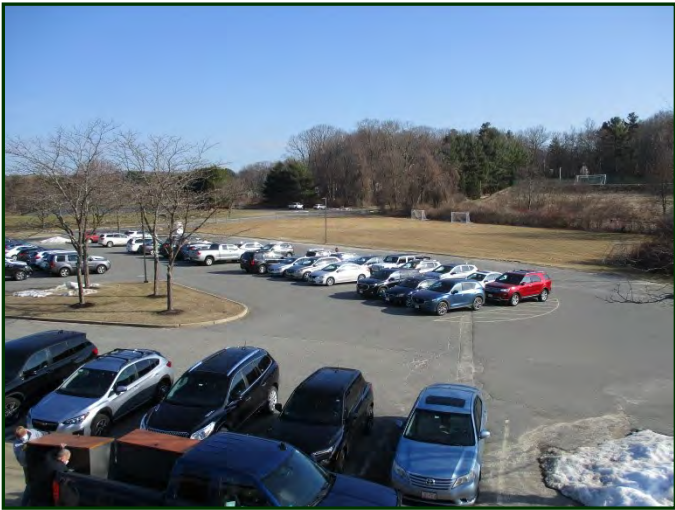
Photo #30: Overview of asphalt-paved parking on east side of site with playing field beyond

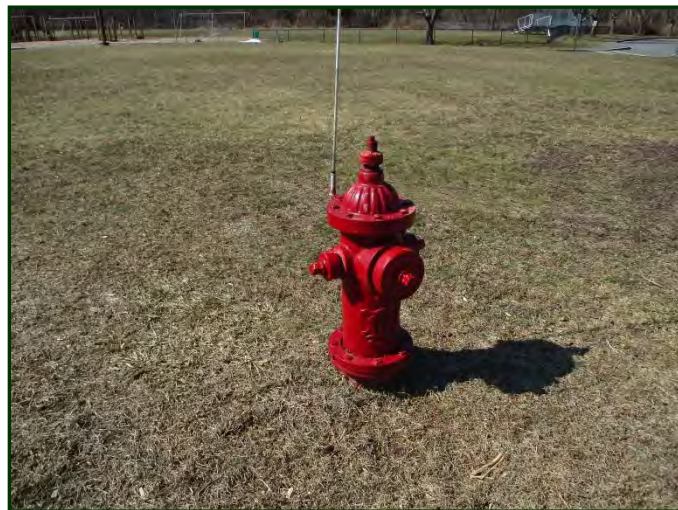
Photo #32: Fire hydrant on-site

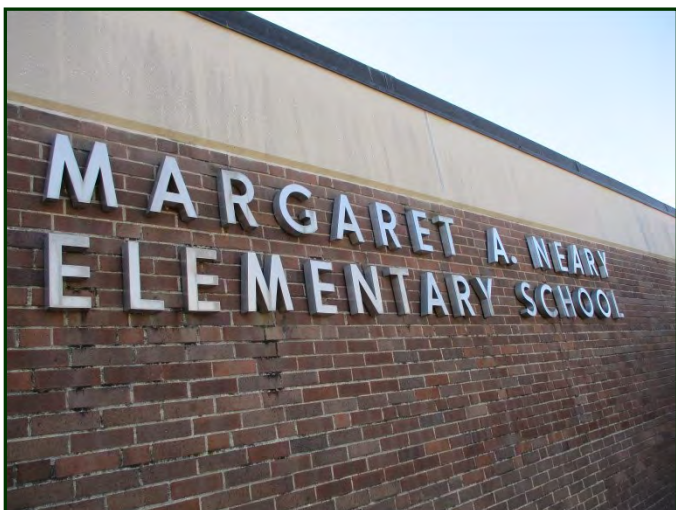
Photo #33: Wall-mounted building sign

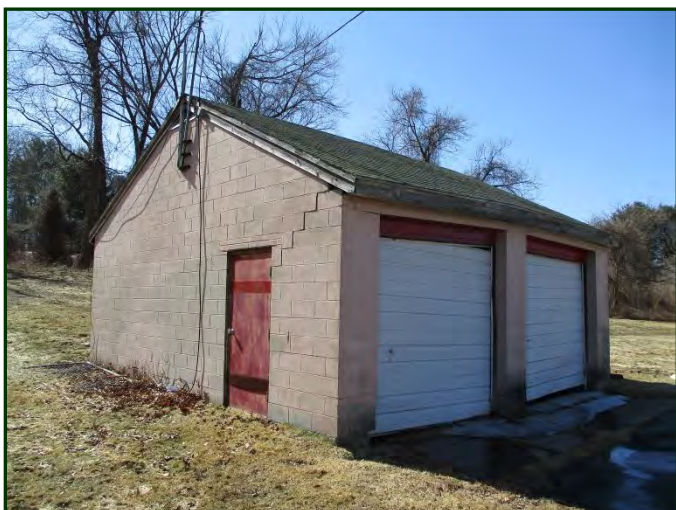
Photo #37: View of (no longer in use) garage at west side of property

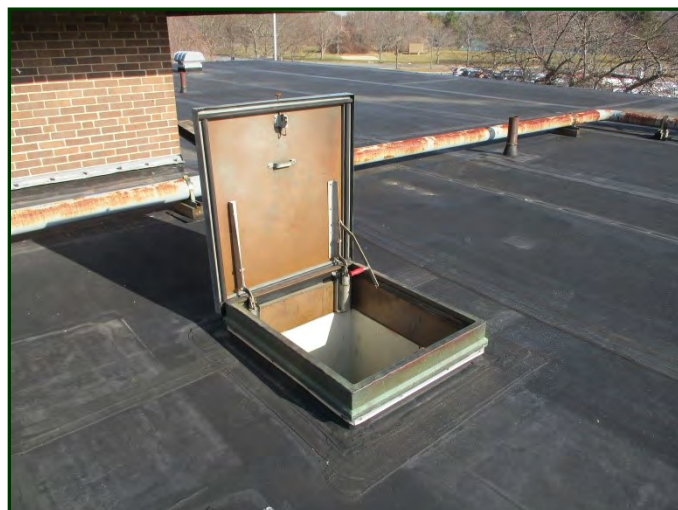
Photo #38: Roof access hatch

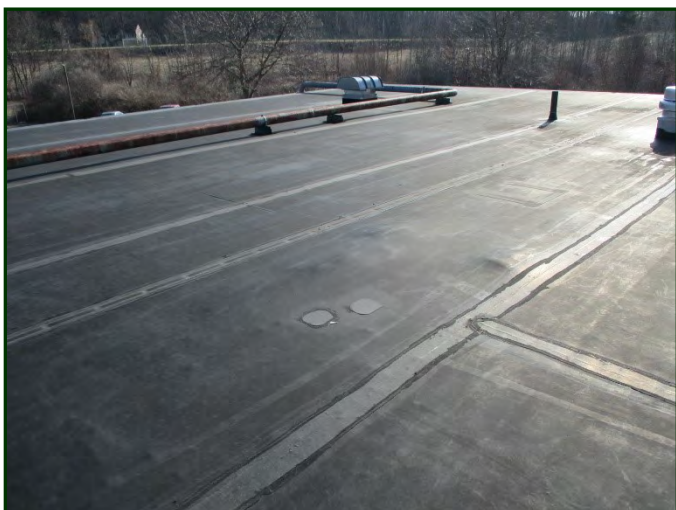
Photo #39: Overview of roof with an EPDM membrane (circa 1990). Note perimeter joints re-seamed & gas line beyond

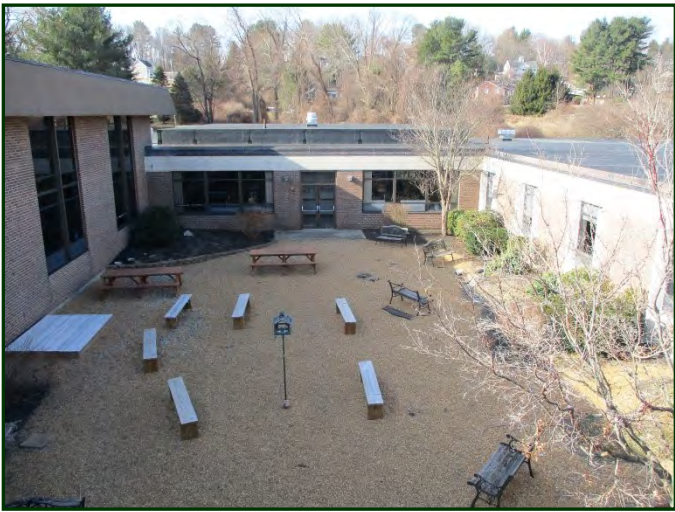
Photo #44: View of courtyard from roof level

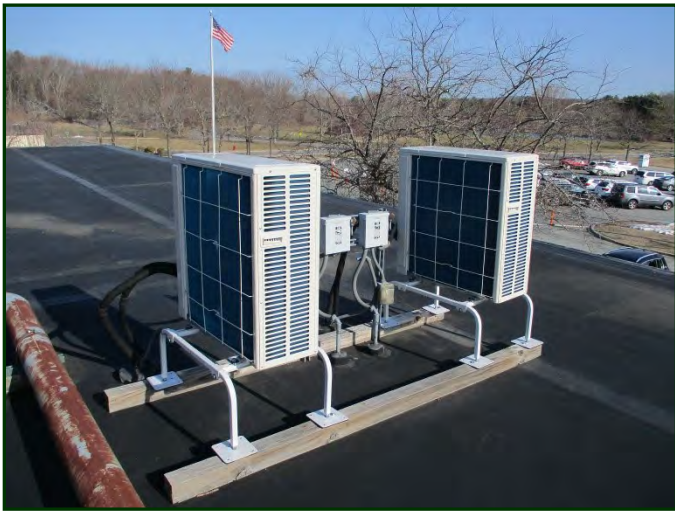
Photo #45: Roof-mounted condensers serving interior duct-less mini-splits (circa 2019)

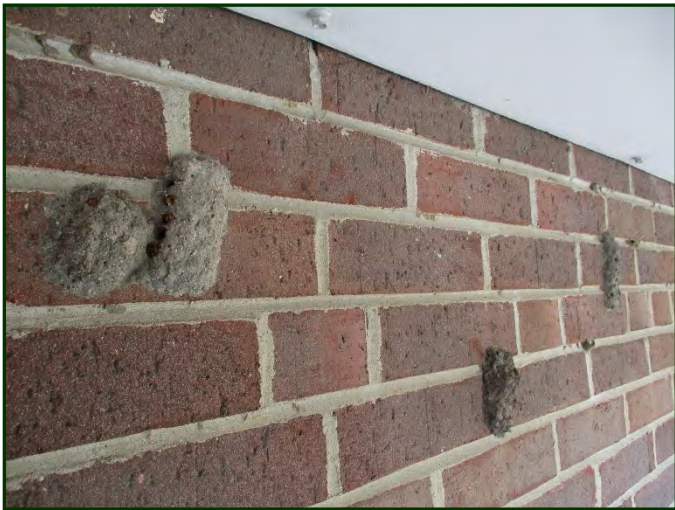
Photo #51: Wasp-bee nests on high walls

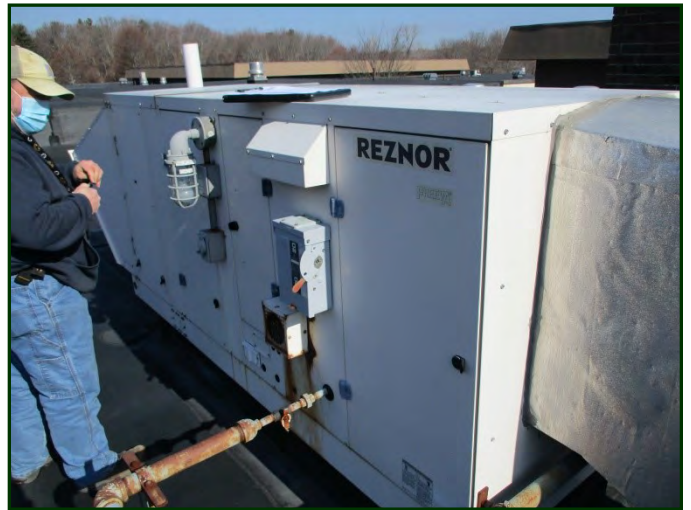
Photo #52: Gas-fired roof-mounted heater supplying tempered air to boiler room below (circa 2008)

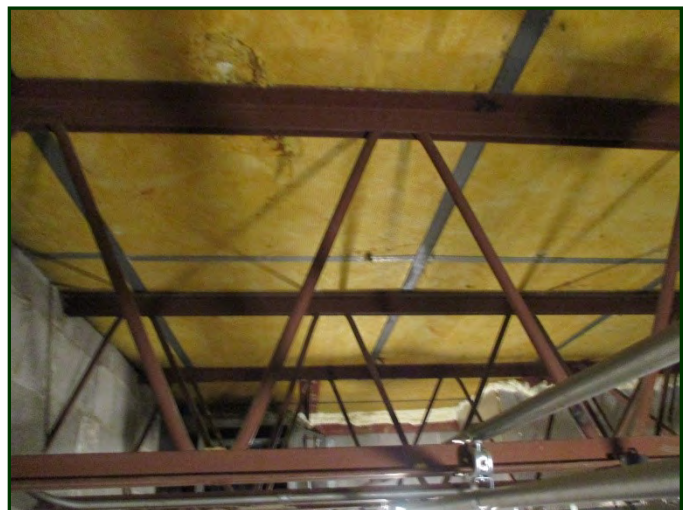
Photo #54: Superstructure with gypsum board roof decking on open web steel bar joist on load bearing CMU walls (predominately)

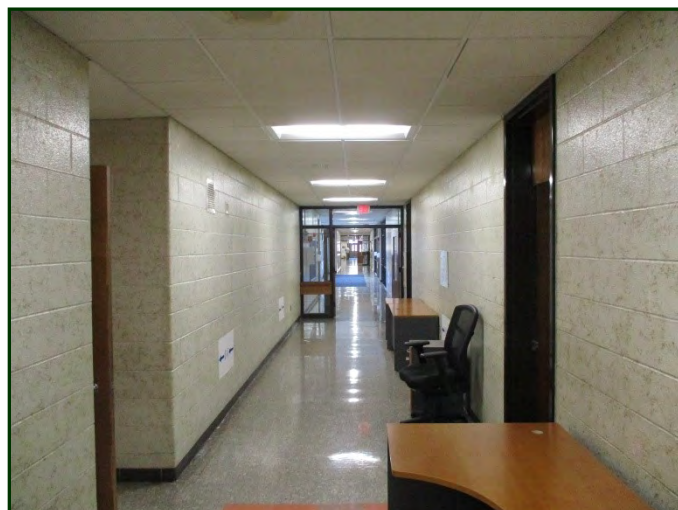
Photo #56: Corridor with (reported) VAT flooring, epoxy painted CMU walls and suspended acoustical ceiling system

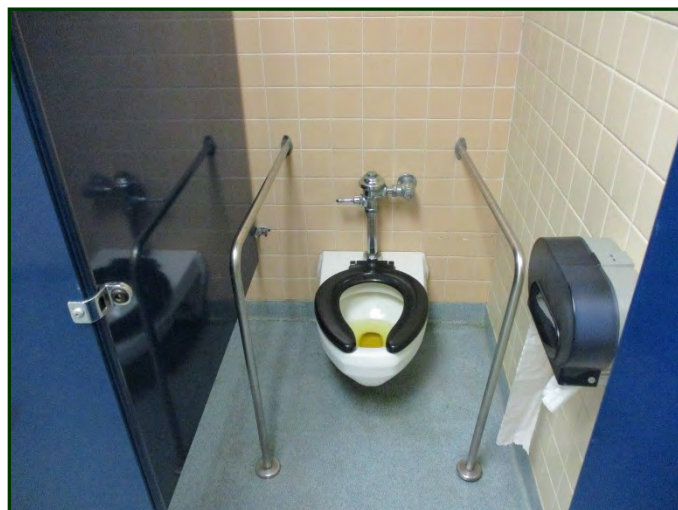
Photo #58: Toilet stall with grab bars

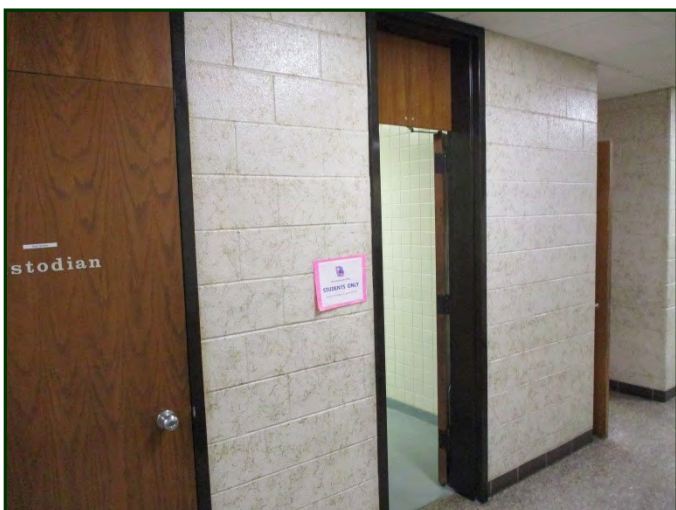
Photo #59: Student toilet room with non-accessible doorway (too narrow for ADA compliance)-typical

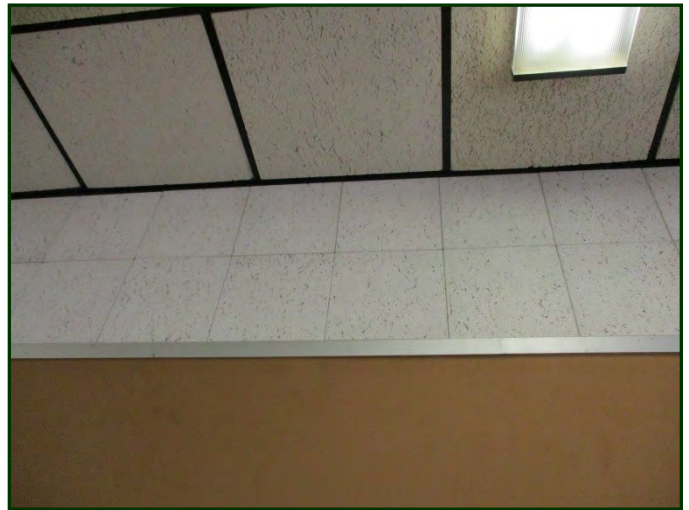
Photo #62: View of acoustical wall tiles in classrooms

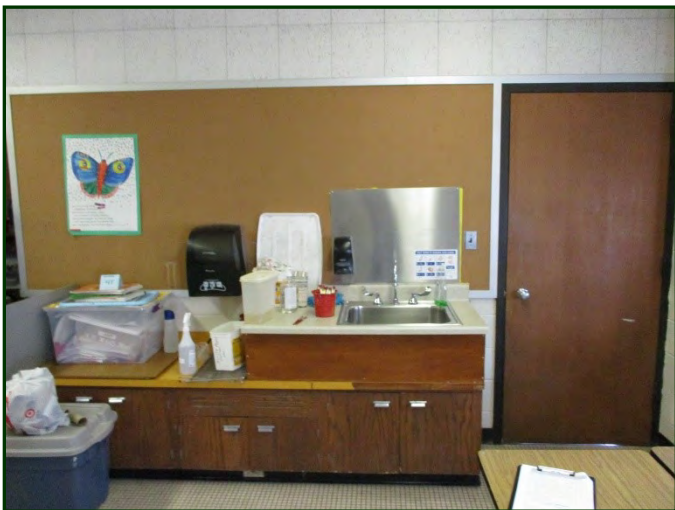
Photo #63: Typical classroom with original (aged) wood case-work modified for higher height sink

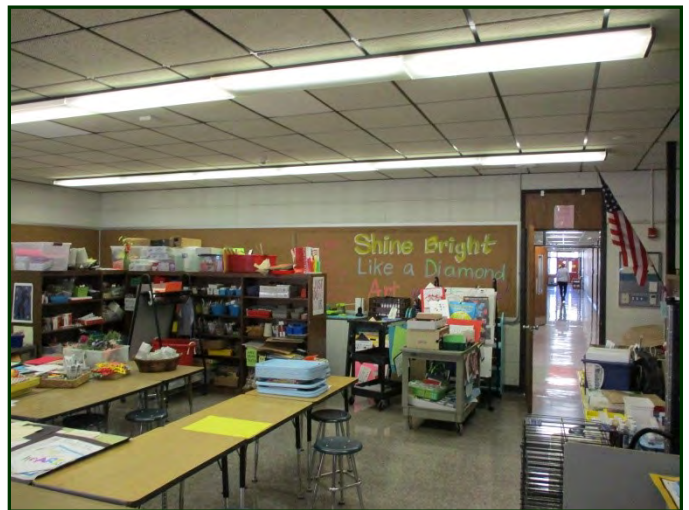
Photo #64: View of typical classroom. Note knob-type hardware at door beyond

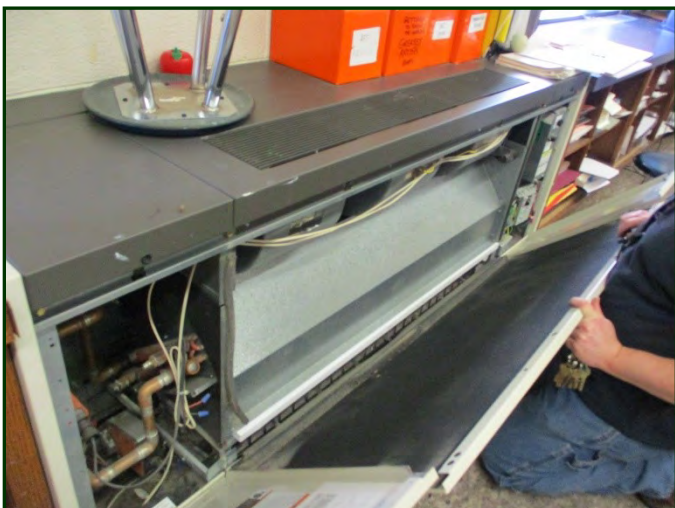
Photo #65: Newer unit ventilators (circa 2009 approximately) with hot water coils (supplies heat & fresh air) at classrooms-typical

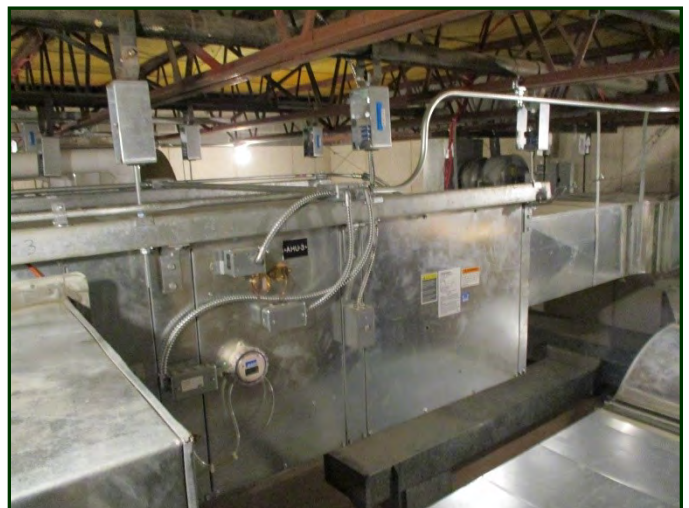
Photo #66: One of three air handling units on mezzanine (circa 2010) supplies heat & ventilation to library, hallway, auditorium & Learning Center

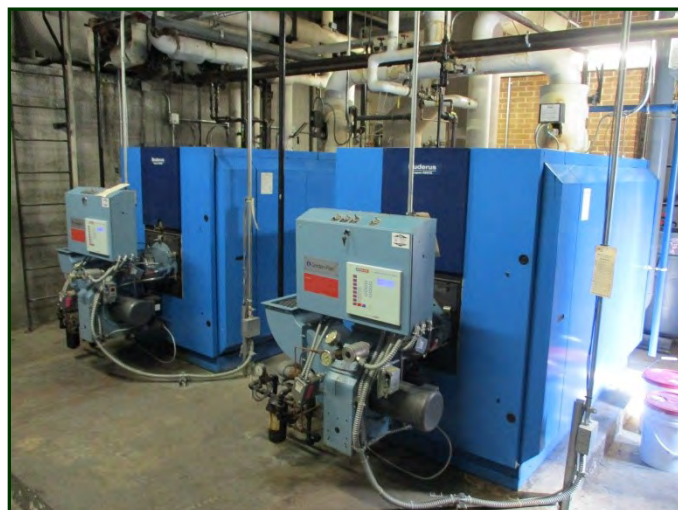
Photo #68: Gas-fired boilers in boiler room (circa 2006)

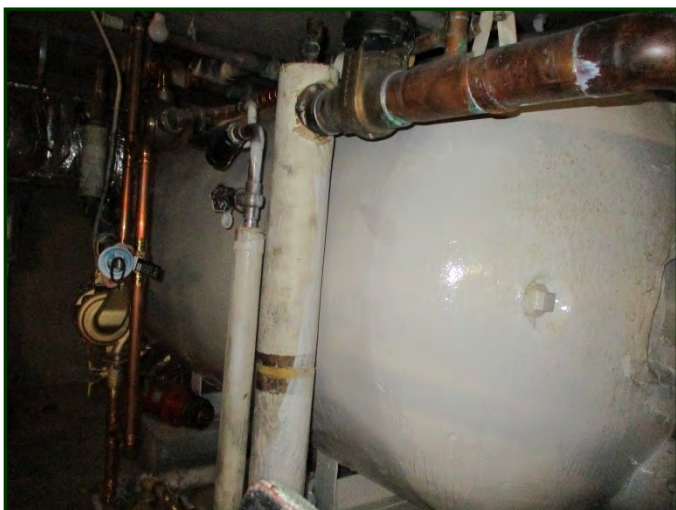
Photo #69: Original indirect-fired water storage tank used for heating months, in boiler room

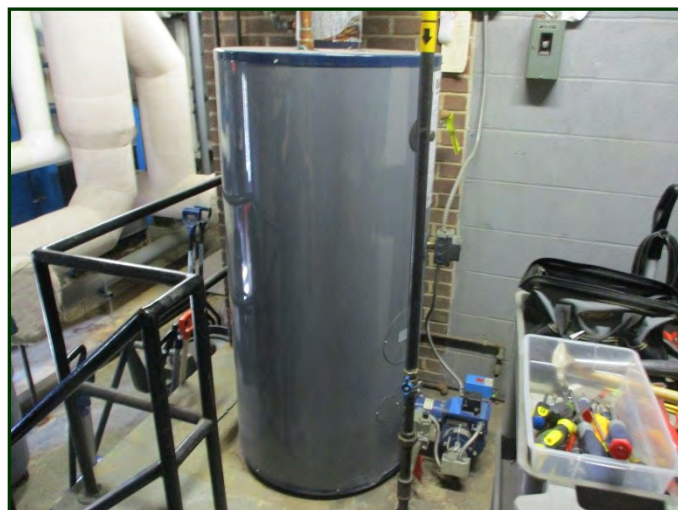
Photo #70: Gas-fired domestic water tank for non-heating months, in boiler room (circa 2016)

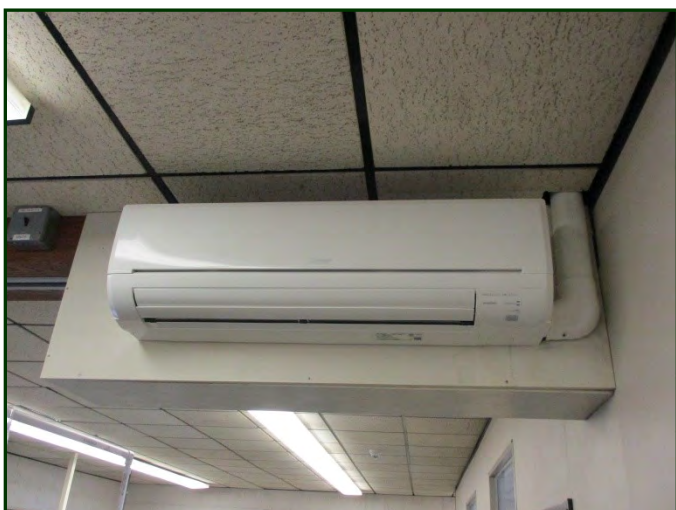
Photo #71: Ceiling-mounted ductless mini-split AHU in office area

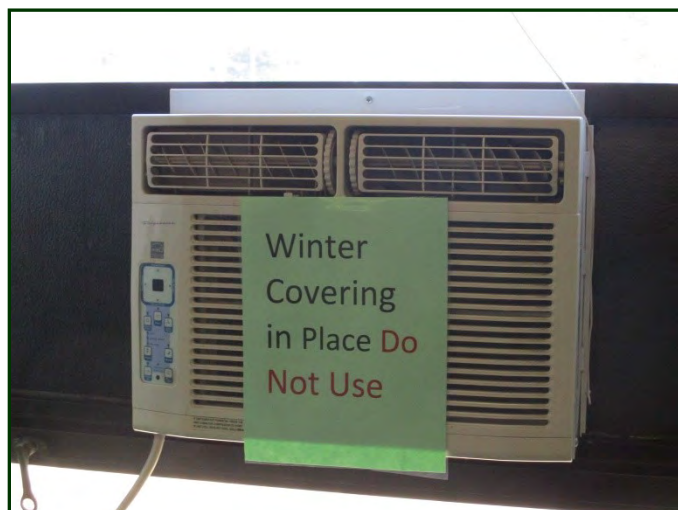
Photo #72: Through-window air conditioning unit

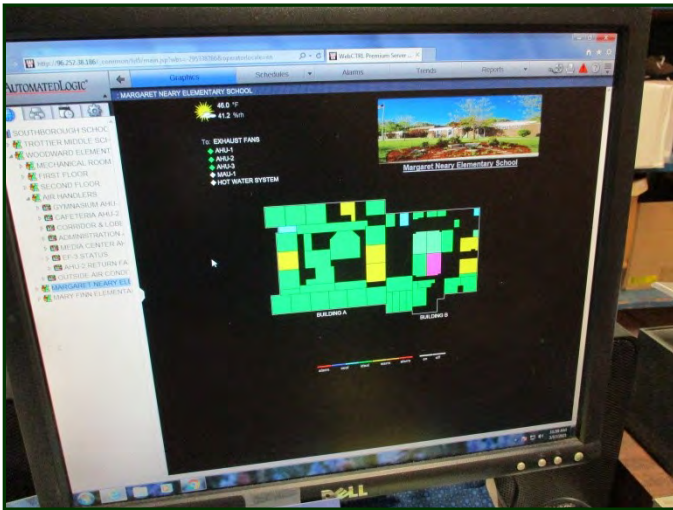
Photo #73: Building’s web-based energy management system

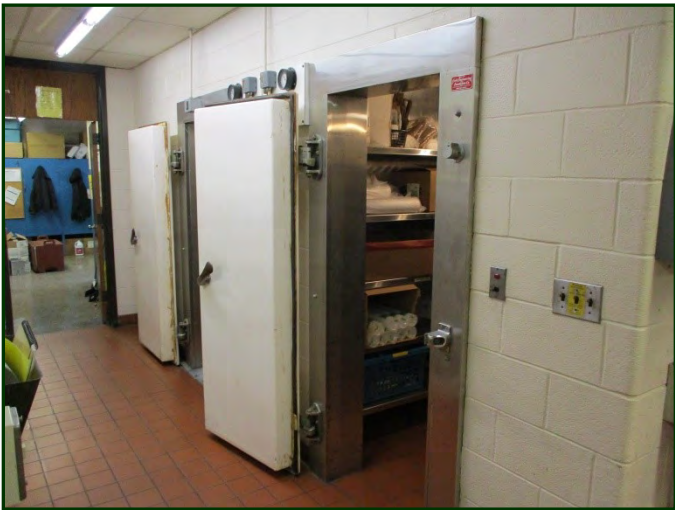
Photo #74: Walk-in cooler and walk-in freezer in kitchen area

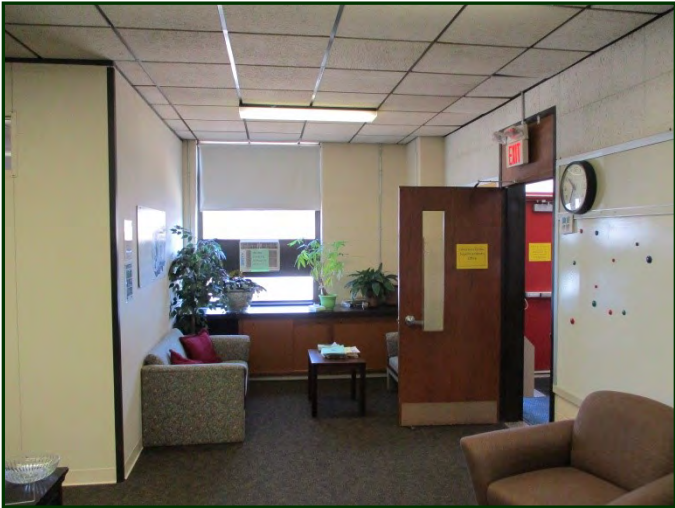
Photo #76: Office area with carpet floor

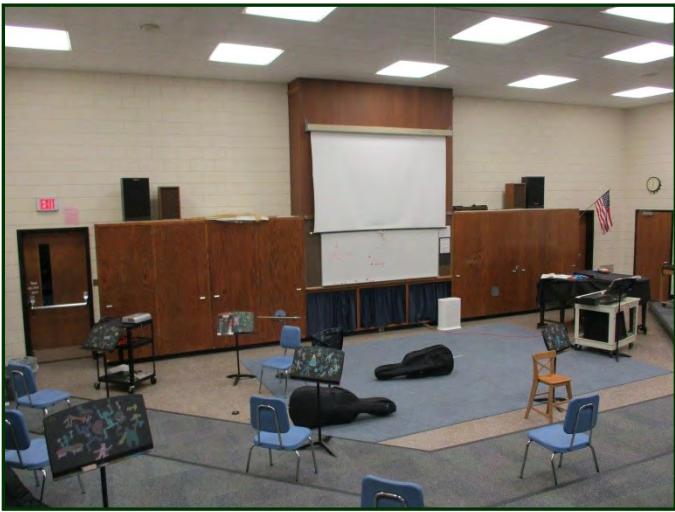
Photo #80: Auditorium with (tiered) carpet floor

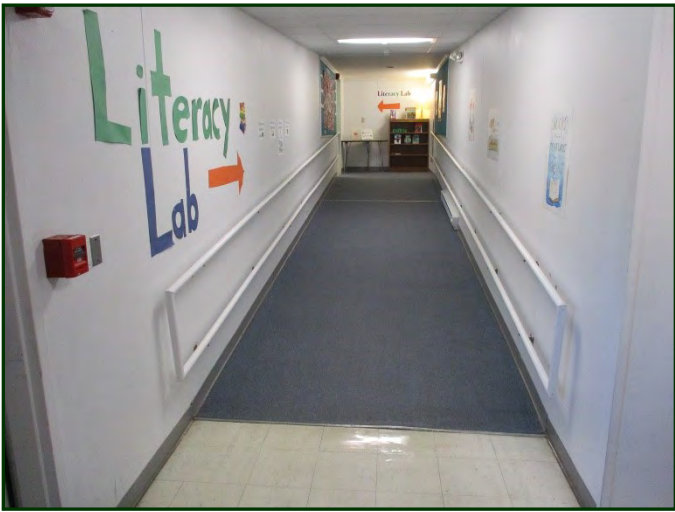
Photo #86: Ramp with carpet & metal handrails serving modular classrooms

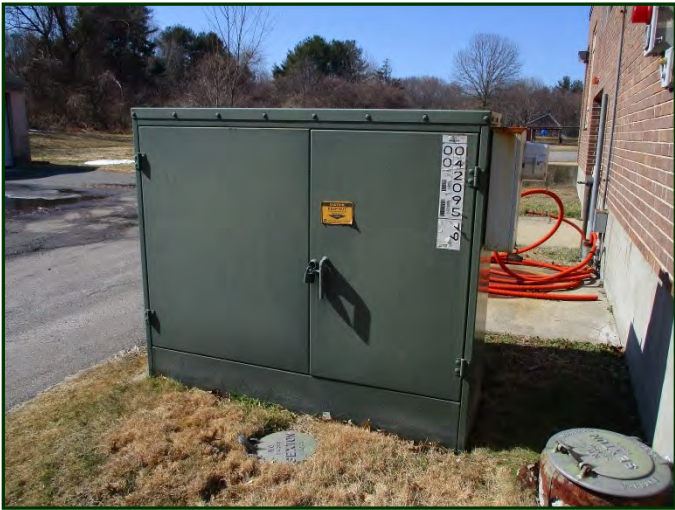
Photo #90: Pad-mounted electrical transformer

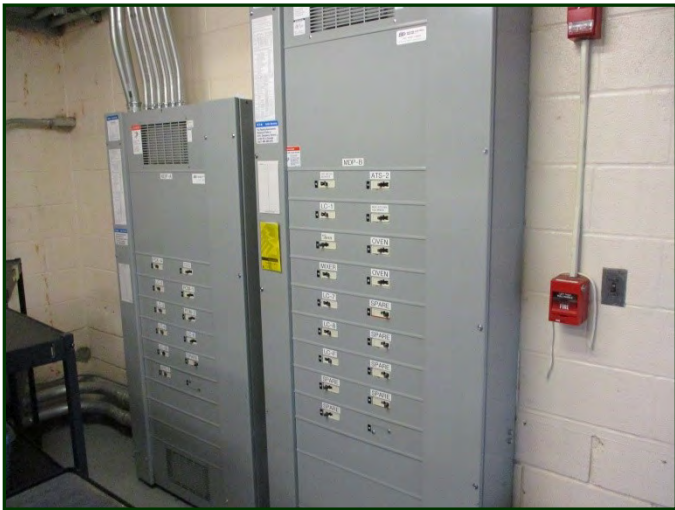
Photo #91: Main electrical switchgear

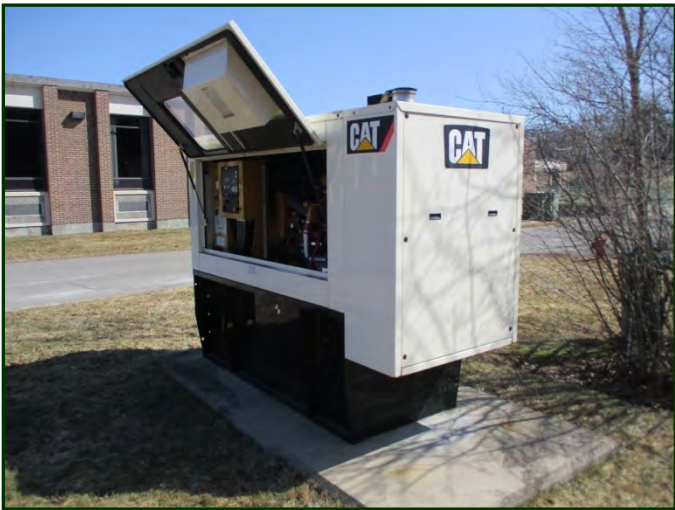
Photo #92: Diesel-fueled emergency generator on concrete pad at rear of building

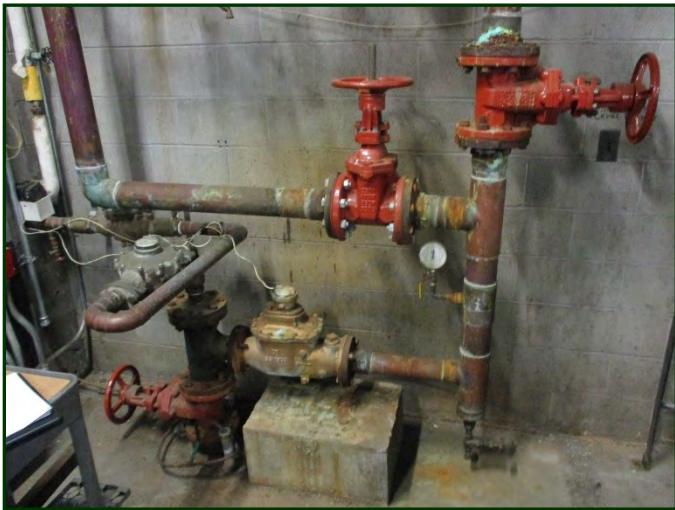
Photo #93: Domestic water service with backflow preventer in boiler room

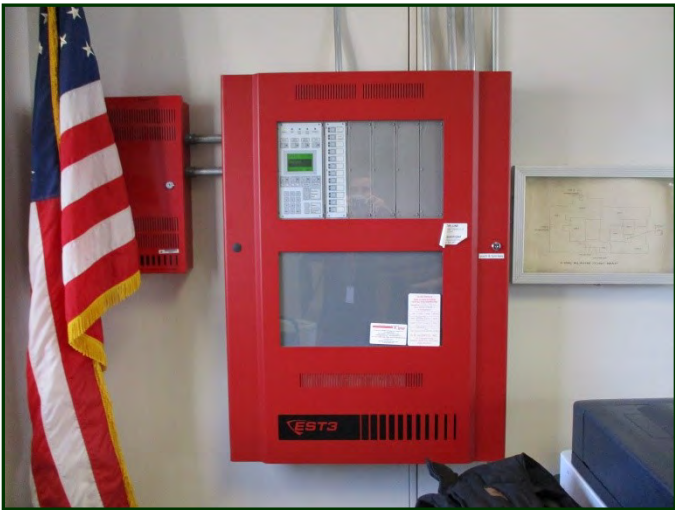
Photo #94: Fire alarm control panel in office adjacent to main building entrance

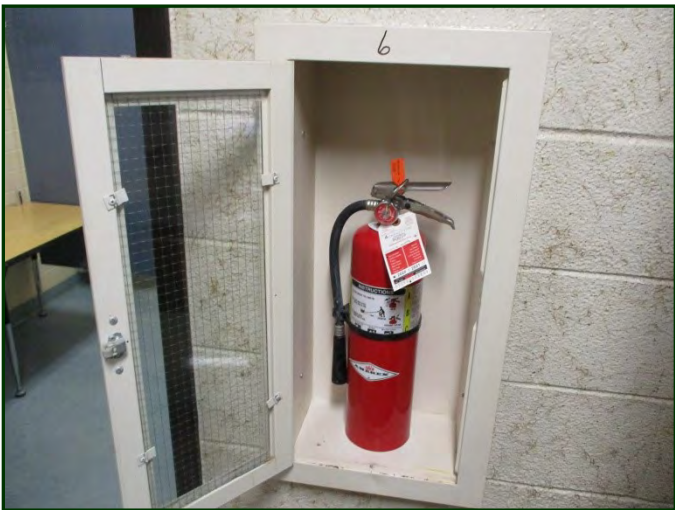
Photo #96: Fire extinguisher in wall cabinet with current inspection tag

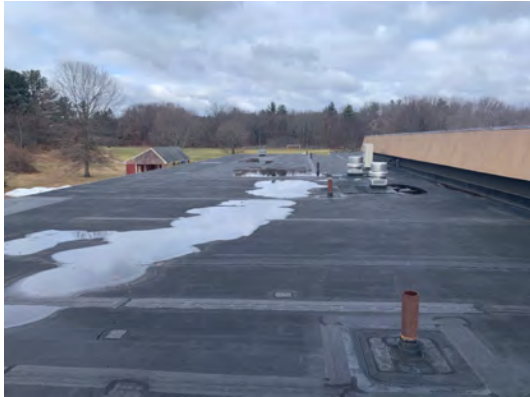
Photo 5

More severe ponding.

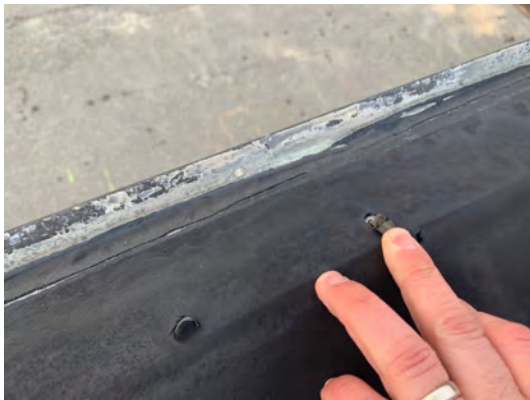
Photo 6

The nails on the wood blocking around the perimeter of the roof are protruding through the membrane.

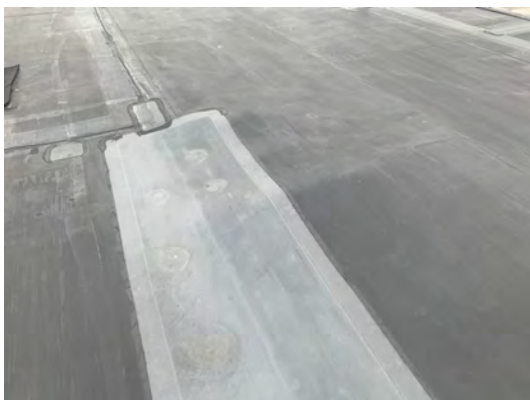
Photo 7

Better view of the lift insulation which is evident in multiple places on this roof.

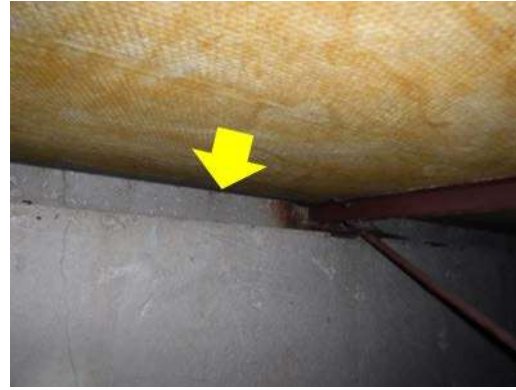
- Attic/Roof – The roof is flat; additional disruptive investigation would be necessary to determine the condition of the roof insulation. Air sealing is recommended at the perimeter of the building where the roof assembly meets the wall assembly.
- Walls – The walls are brick exterior and structural block; there is no cavity in this wall assembly that would allow retrofit insulation.
- Windows – The windows are single pane fixed sash and hopper units. Air conditioning units are installed through select window systems.
- Doors – There are air leaks at the perimeter of the door systems throughout the facility.

Roof-Wall Intersection Sealing Opportunity
