# Evaluation of Southborough Sites

# Existing Conditions Report

# Structural Conditions

## INTRODUCTION

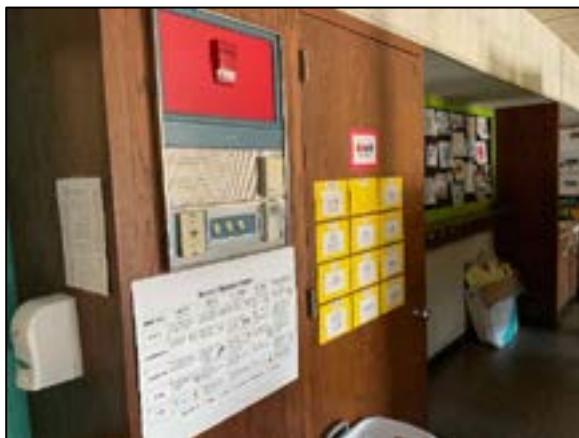
FIGURE 4: CLASSROOM WALL DECORATIONS

**On site, decorations were observed to be mounted on walls in classrooms and corridors. Regardless of the scope of work, it is recommended that paper decorations be reviewed throughout to ensure these materials are within the allowable limits and locations.**

- Paper materials displayed in classrooms are not permitted to exceed 50% of the total wall area where buildings are sprinklered throughout (527 CMR 20.2.4.4.3). Otherwise, paper materials are permitted for up to 20% of the total wall area.

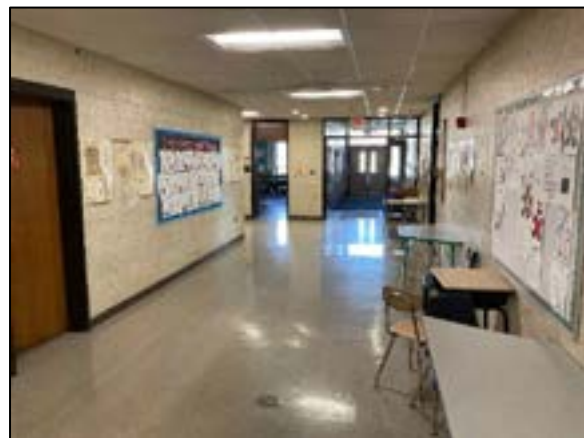
FIGURE 5: CORRIDOR WALL DECORATIONS

- Paper materials displayed in corridors are not permitted to exceed 50% of the surface area of any wall in buildings sprinklered throughout, or 10% if the building is not sprinklered (527 CMR 20.2.4.4.4).
  - Paper materials are required to be positioned in such manner to avoid concentration of materials to reduce flame spread in the event of a fire.
  - Groupings of materials are not permitted to exceed a maximum horizontal measurement of 12 feet and a maximum vertical measurement of six feet.
  - Groups of paper material are permitted as long as there is space between each group equal to at least ½ the horizontal width of the largest adjacent group.
- Paper materials are not permitted to cover an egress door or be placed within 5 ft. of an egress door (527 CMR 20.2.4.4.).

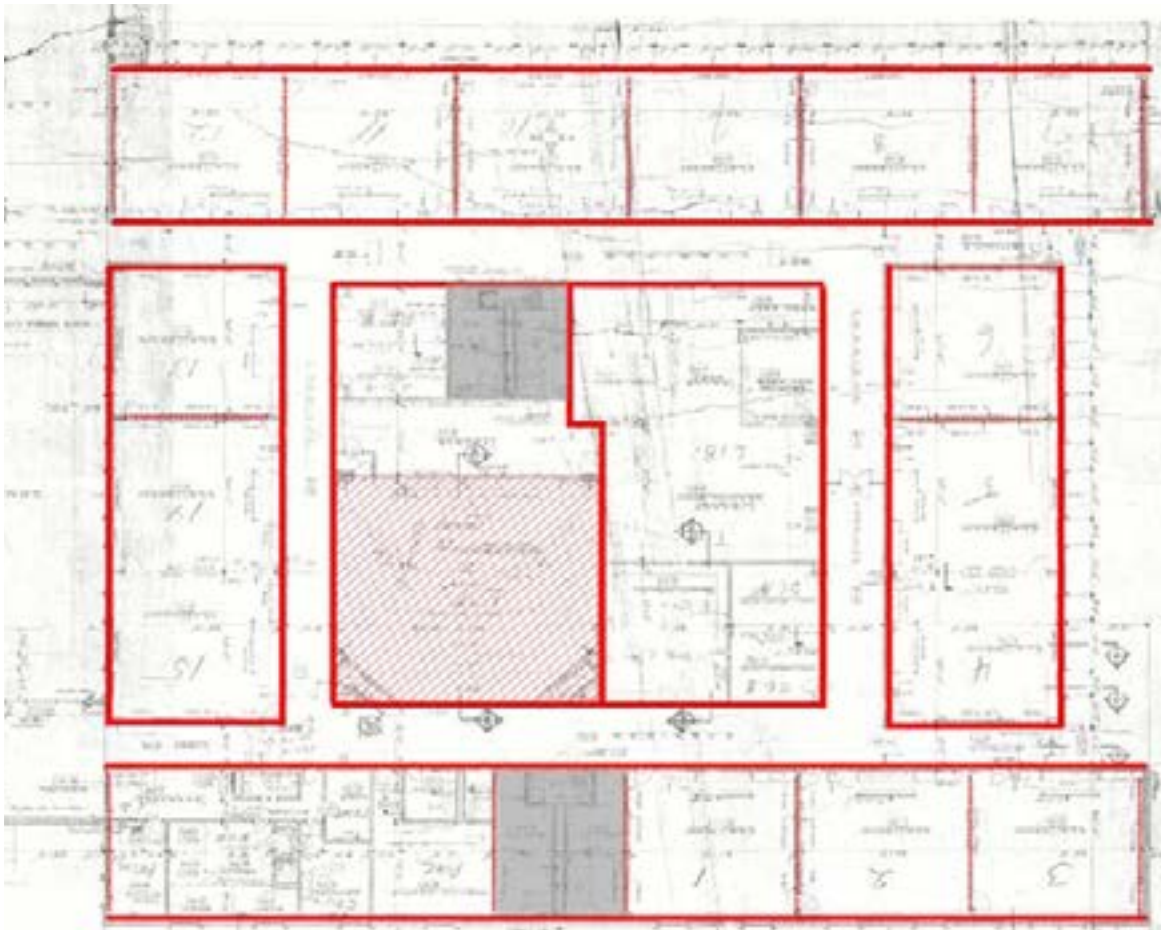
Existing Bearing Wall Diagram

The diagram below describes the extent of bearing walls. Any renovation Options would need to carefully consider the structural impact and associated cost of removing any of these walls.

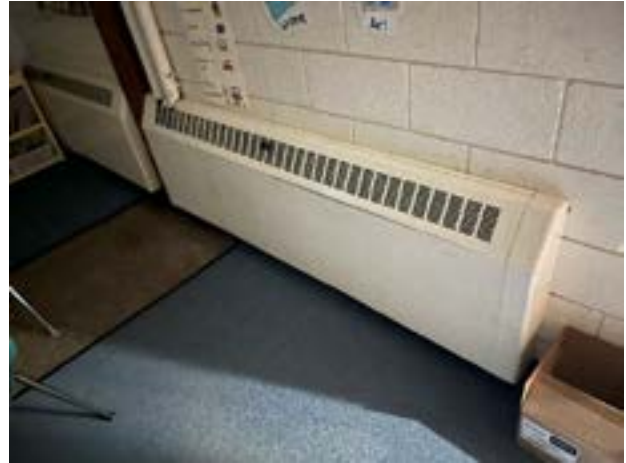
*Typical Hot Water Fin Tube Radiation*

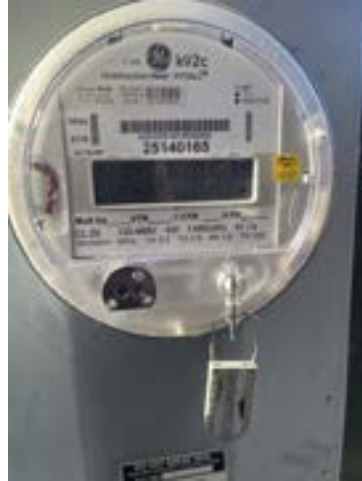
*Utility Meter*

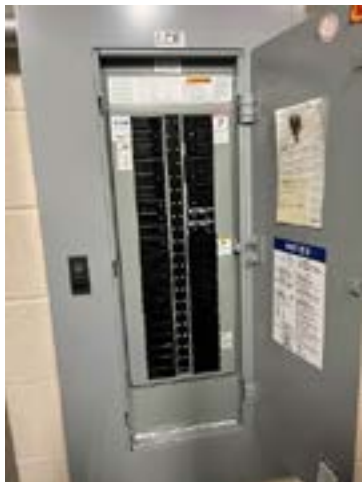
*2011 Vintage Panelboard*

1. Main Distribution Panel “MDP” and all 2011 vintage sub-panels are in good condition, however the capacity at 6.6W/SF is inadequate for a substantial renovation. Therefore a new primary service, and new secondary service should be provided. The service will be sized to 15W/SF at 277/480V (for all-electric HVAC system) the 2011 equipment can be backfed and re-used. Replace the entire electrical distribution system with new, Existing branch circuits to connect to new panels in areas of minor renovation.

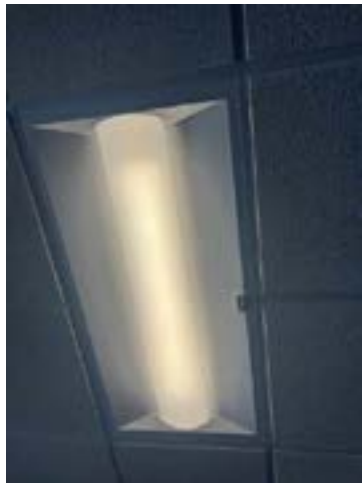
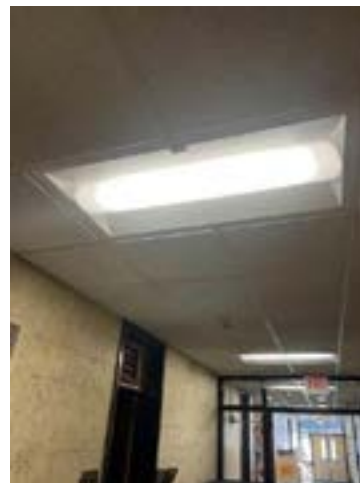
Corridor lights generally consists of 2'x4' recessed LED fixtures with integral sensors.

*Corridor Fixture*

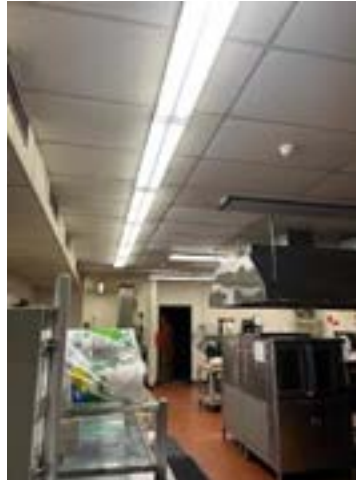
The kitchen contains surface mounted two lamp cross section fluorescent wraparound fixtures with LED lamps.

*Kitchen*

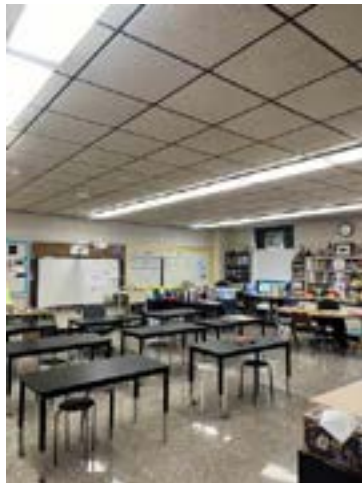
Classroom lighting consists of (3) rows of 2 lamp cross section linear fluorescent wraparound light fixtures that have been retrofit with LED lamps. Light switches are built into and part of the Simplex clock/speaker cabinet.

*Linear Fluorescent Wraparound Fixtures*

2. Provide automatic lighting control system in combination with automatic dimming sensors throughout.
3. Replace non-LED lighting to LED source and provide dimming photo sensor within areas with natural daylight to dim fixtures automatically.

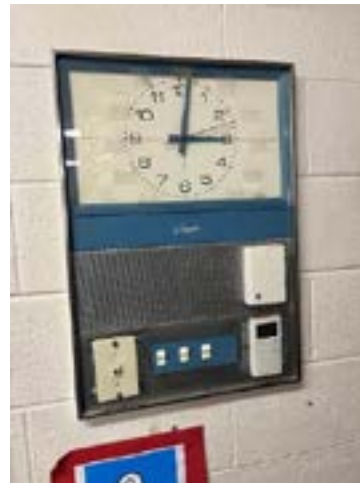
*Simplex Clock/Speaker Cabinet*

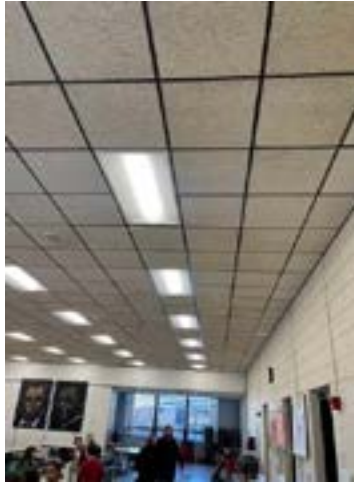
Cafeteria has 2'x4' recessed LED fixtures with integral sensors.

*Cafeteria Lighting*

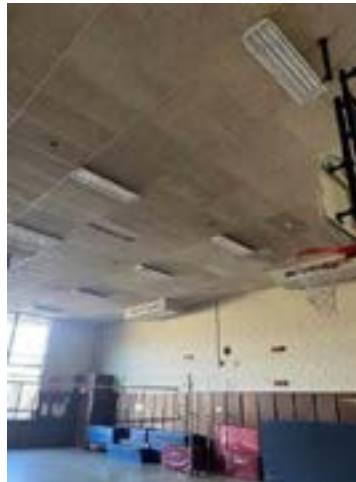
The gymnasium contains 4 lamp cross section fluorescent T5HO 2'x4' surface mounted high bays with a wire guard. Each fixture contains an integral occupancy sensor.

*Gym Lighting*

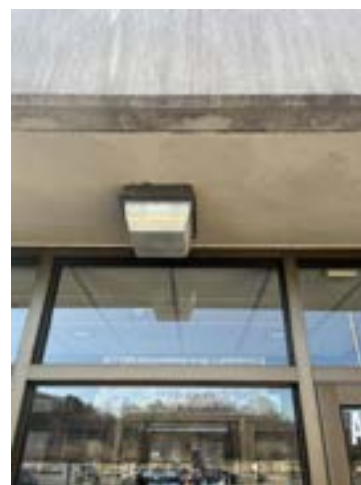
*Exterior Canopy Light*

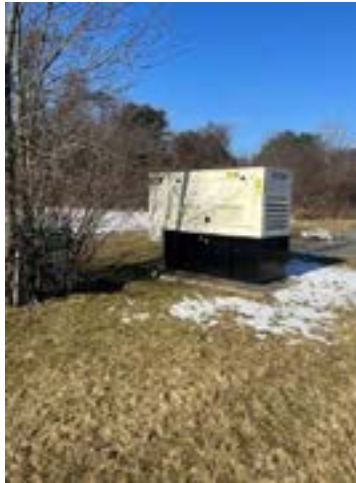
The generator is a diesel fired generator, 120/208 Volt, 3-Phase, 4 Wire, manufactured by Caterpillar and is located outside at the rear of the building.

*Generator*

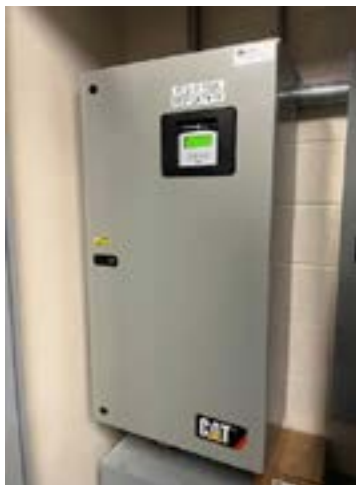
There is separation of the life safety and optional standby loads. The automatic transfer switches are located in the electrical room and are manufactured by Caterpillar.

*Transfer Switch*

8. A system of new automatic transfer switches and panelboards should be provided (if an electric HVAC system option is selected).
9. The existing fire alarm system is non-code compliant and should be replaced with new addressable system with voice evacuation in compliance with code.

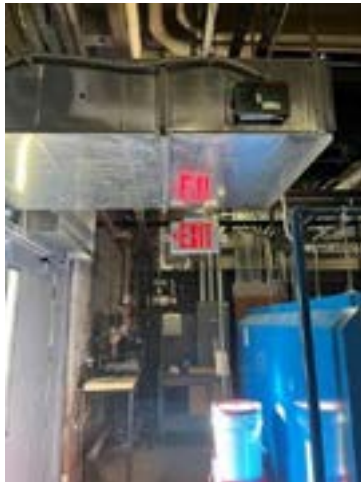
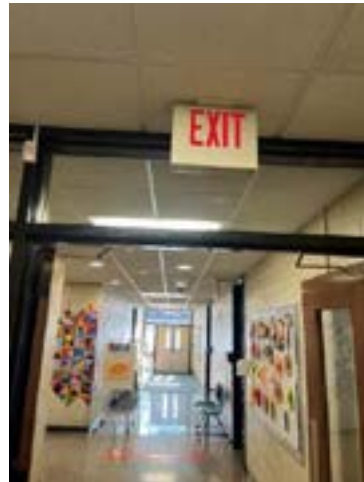
Life safety lighting and exit signs are in fair condition and seem to be compliant.

*Exit Sign*

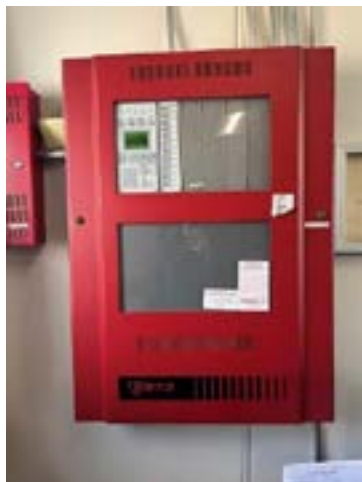
The fire alarm consists of an Edwards addressable panel. The FACP is located in the admin area of the main lobby. The fire alarm system does not contain voice evacuation.

*FACP*

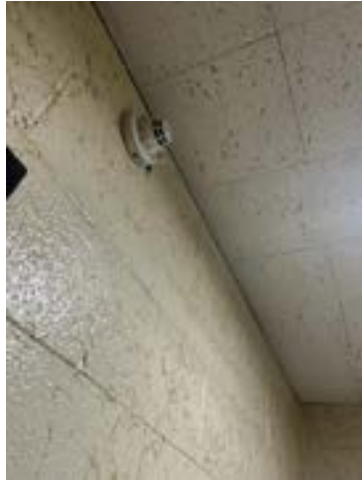
*Smoke Detector*

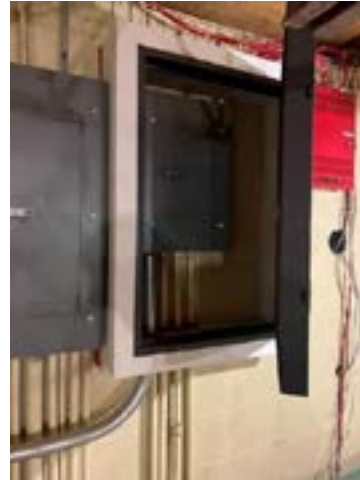
*Low Energy Cable*

Low energy fire alarm wiring is used throughout the building.

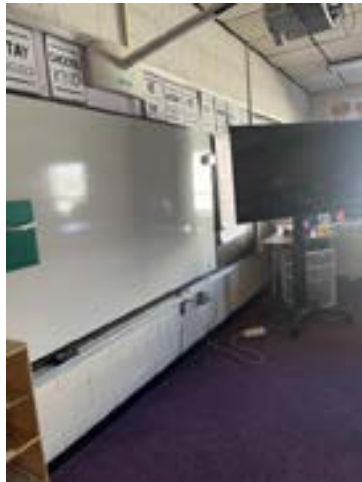
The receptacle coverage is inadequate in most spaces. Typical classrooms have two or three receptacles, new receptacles have been added in many classrooms to support Classroom A/V.

*New Receptacle*

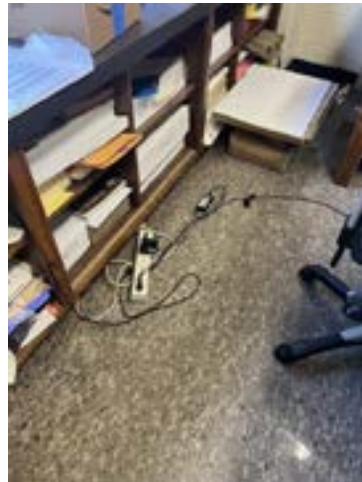
Extension cords are used throughout classrooms and offices due to lack of receptacles. The use of extension cords for permanent wiring is a code violation.

*Extension Cords*

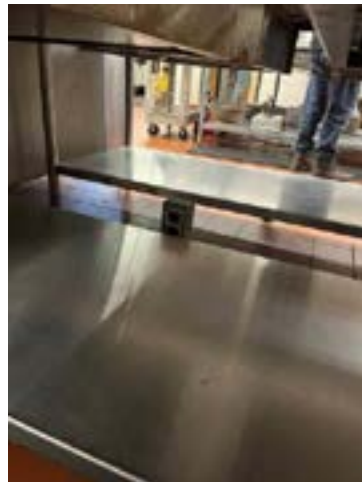
*Kitchen Receptacle*

GFCI protection is missing in the kitchen.

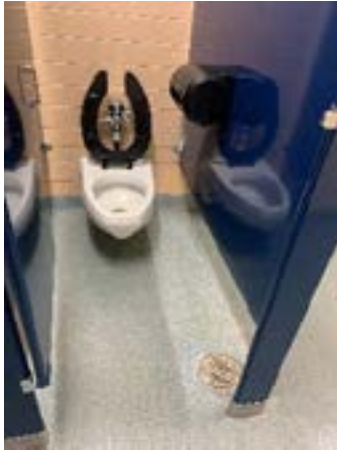
The plumbing fixtures are in fair condition. Attempts have been made to make bathroom fixtures accessible, however, most of the plumbing fixtures do not meet current accessibility codes. In general, the fixtures appear to have served their useful life. The Current Access Code requires accessible fixtures wherever plumbing is provided. In terms of water conservation fixtures, their use is governed by the provisions of the Plumbing and Building Code. Essentially, the code does not require these fixtures to be upgraded, but where new fixtures are installed, as may be required by other codes or concerns, the new fixtures need to be water conserving type fixtures. All new plumbing fixtures are recommended.

*Water Closet*

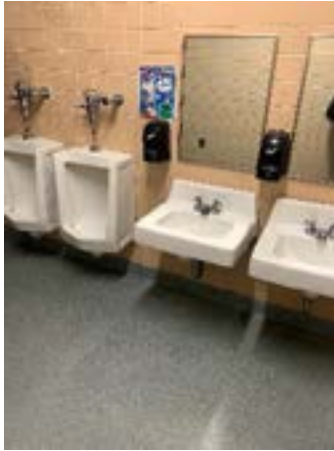
*Urinals*

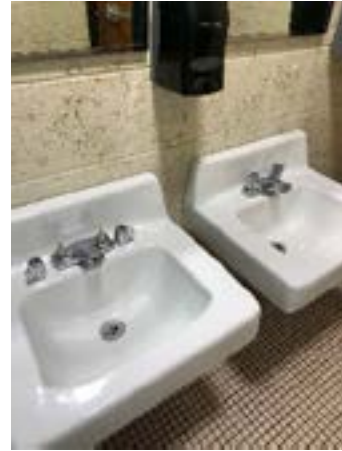
*Lavatories*

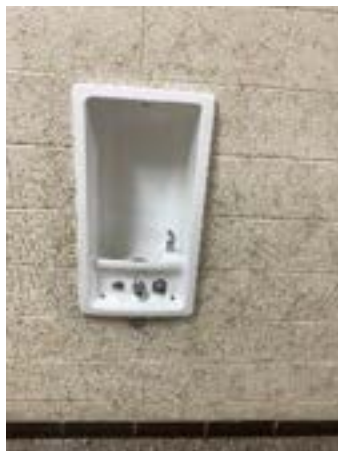
Drinking fountains consist of wall hung vitreous china fountains.

*Drinking Fountain*

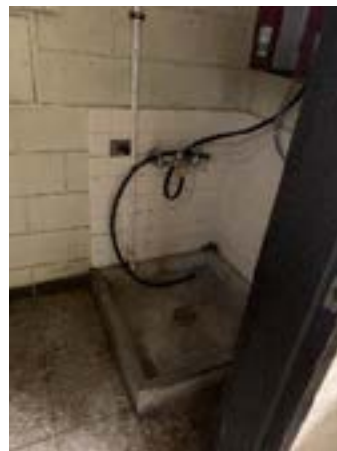
Janitor's sink are generally terrazzo floor receptors. Faucets are equipped with vacuum breakers.

*Mop Receptor*

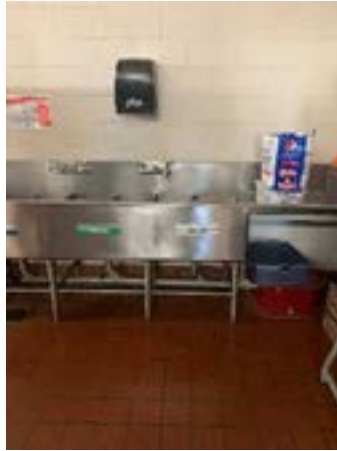
Kitchen area fixtures are in good condition. The pot washing sink is fitted with an on-the-floor grease interceptor.

*Pot Sink*

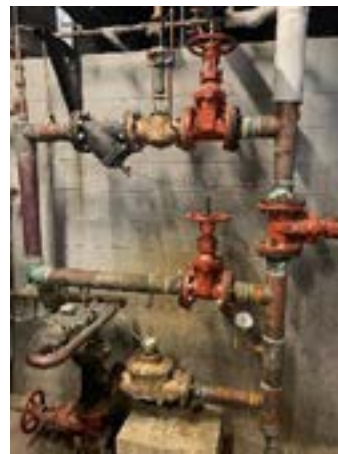
*Water Meter*

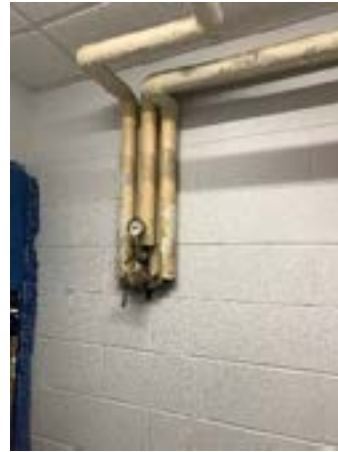
*Mixing Valve*

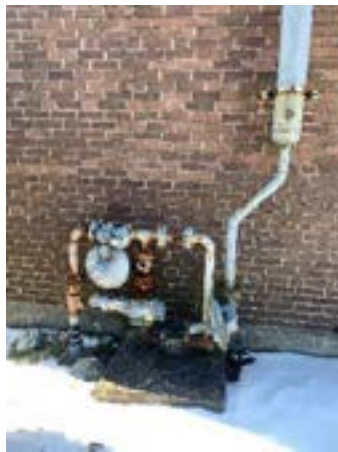
Natural gas is provided for kitchen cooking equipment. The kitchen supply is not equipped with an automatic shutoff valve.

*Gas Service*

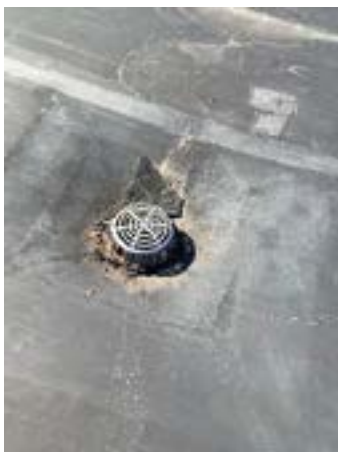
Cast iron is used for sanitary and storm drainage. Where visible, the cast iron pipe appears to be in fair condition. Smaller pipe sizes appear to be copper. In general, the cast iron drainage piping can be reused even in a major renovation where adequately sized for the intended new use.

*Roof Drain*
